## **Access Compliance Report Public Rights-of-Way** (Curb Ramps)

Intersection ID: 21073 Main Street: COLONY RD Cross Street: SHARON\_VIEW\_RD Location: NW **ADA ID: 8F4AD05AF4A8** Ramp Type: Perpendicular Diagonal Initial Pass/Fail: Fail **Overall Compliance: No Severity Score:** 37.5

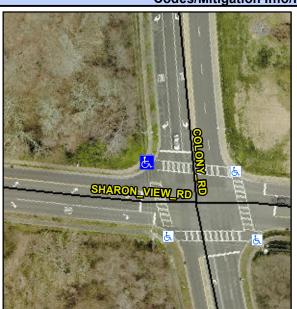
Field Measurements/Component Compliance						
Compliance Description		Data	Comp	liance	Description	Data
N/A	Ramp Length (in)	51.0	No	Ramp	Slope (%)	9.0
Yes	Ramp Width (in)	49.0	No	Ramp	XSlope (%)	10.3
N/A	Flare Type LT	N/A	N/A	Flare	Type RT	N/A
N/A	Flare Slope LT (%)	N/A	N/A	Flare	Slope RT (%)	N/A
N/A	Flare Traversable LT?	N/A	N/A	Flare	Traversable RT?	N/A
N/A	Landing Length (in)	N/A	N/A	DWS	Provided?	N/A
N/A	Landing Width (in)	N/A	N/A	DWS	Contrast?	N/A
N/A	Landing Slope (%)	N/A	N/A	DWS	Length (in)	N/A
N/A	Landing X Slope (%)	N/A	N/A	DWS	Full Width?	N/A
N/A	Landing Curb? (Y/N)	N/A	N/A	DWS	Offset (in)	N/A
N/A	Shared Landing?	N/A				
N/A	Gutter Ponding?	N/A	N/A	Gutte	r Slope (%)	N/A
N/A	Gutter Lip Ht (in)	N/A	N/A	Gutte	r X Slope (%)	N/A
N/A	Painted X Walk1?	Yes	N/A	Painte	ed X Walk2?	Yes
	X Walk 1 Direction	To SE		X Wal	k 2 Direction	To SE
N/A	X Walk 1 Width (in)	138.0	N/A	X Wal	k 2 Width (in)	112.0
	X Walk 1 Slope (%)	0.2		X Wal	k 2 Slope (%)	7.1

X Walk 1 X Slope (%)	8.3		X Wal	k 2 X Slope (%)	4.9
N/A	Ramp inside XWalk1?	Yes	N/A	Ramp	inside XWalk2?	Yes
	Road Slope (%)	9.0	N/A	Clear	Space?	N/A
	Road X Slope (%)	0.9	N/A	Clear	Space to XWalk (in)	N/A
N/A	Any Obstructions?	N/A	N/A	Storm	Grate/Utility Hazard?	N/A
	Obstruction Type			Storm	Grate/Utility Type	
		N/A				N/A
			Yes	Surfac	ce Condition? (G/P)	Good
i English

Possible Solutions: Remove & Replace Curb Ramp With Two New Directional Ramps or Equivalent. Surveyor Notes: N/A PROW/ADA: Not Found, R304.2.2, R304.5.3
