# Access Compliance Report

## Public Rights-of-Way

### (Curb Ramps)

| Intersection ID: 15175 | Main Street: SOUTH_BV | Cross Street: POINDEXTER_DR | Location: NW |

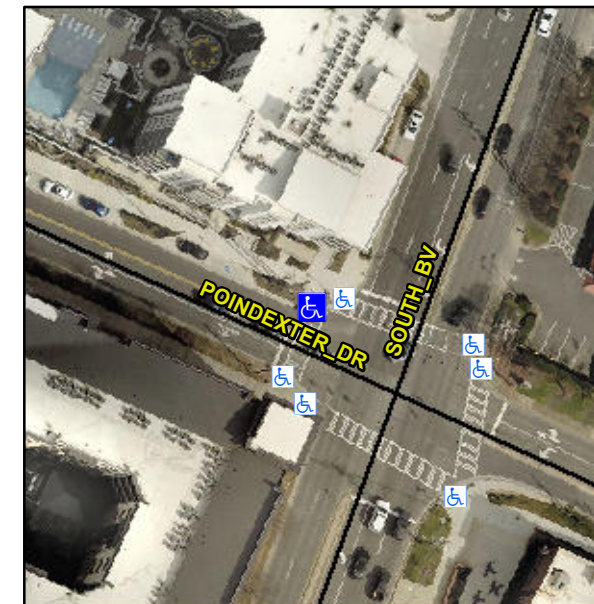
| ADA ID: 8F4D786FD42D | Ramp Type: Perpendicular | Initial Pass/Fail: Fail | Overall Compliance: No |

**Not Found, R304.2.2**

| Compliance | Description | Data | Compliance | Description | Data |
|---|---|---|---|---|---|
| N/A | Ramp Length (in) | 80.0 | No | Ramp Slope (%) | 8.8 |

**Remove & Replace Entire Ramp.**

Total Cost: \$ 1850.00
