# Access Compliance Report

## Public Rights-of-Way

| Intersection ID: 43676 | Main Street: SARDIS_COMMONS_LN | Cross Street: SARDIS_RD | Location: NW |
| ADA ID: 8F5236C15453 | Ramp Type: Perpendicular Diagonal | Initial Pass/Fail: Fail | Overall Compliance: No<br>Severity Score: 21.25 |

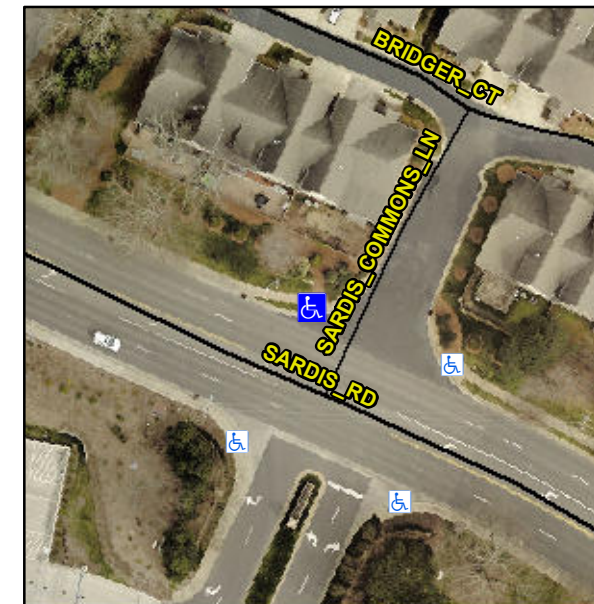
**Not Found, R304.5.1, R304.2.2**

| Compliance | Description | Data | Compliance | Description | Data |
|---|---|---|---|---|---|
| N/A | Ramp Length (in) | 48.5 | No | Ramp Slope (%) | 10.9 |
| No | Ramp Width (in) | 45.5 | Yes | Ramp XSlope (%) | 0.9 |

**Remove & Replace Curb Ramp With Two New Directional Ramps or Equivalent.**

Total Cost: \$ 3200.00
