# Access Compliance Report

## Public Rights-of-Way

### (Curb Ramps)

Intersection ID: 14785	Main Street: ALBERTO_ST	Cross Street: CIRCLE_AV	Location: SE
ADA ID: 8F52E506FC4A	Ramp Type: Directional1	Initial Pass/Fail: Fail	Overall Compliance: No
Severity Score: 25			
Codes/Mitigation Info/Possible Solution		Field Measurements/Component Compliance

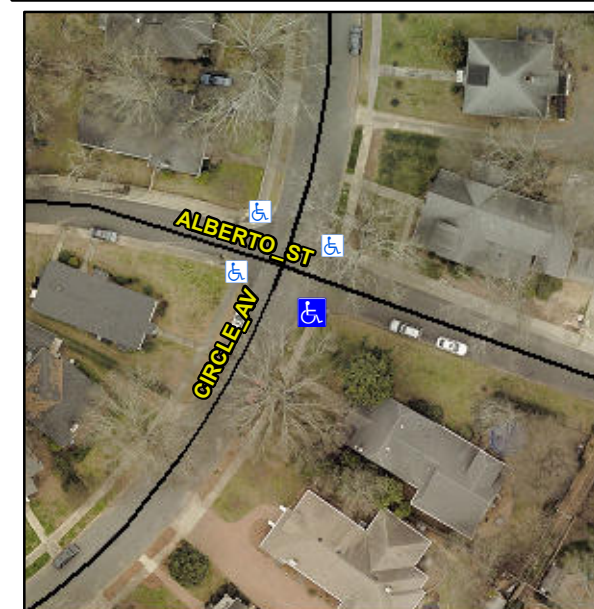
Compliance	Description	Data	Compliance	Description	Data
N/A	Ramp Length (in)	57.0	N/A	Grade Break?	N/A
Yes	Ramp Width (in)	58.5	N/A	Grade Break Slope (%)	0.0
Yes	Ramp Slope (%)	5.3	N/A	Grade Break XSlope (%)	0.0
No	Ramp XSlope (%)	8.4			
N/A	Flare Type LT	N/A	N/A	Flare Type RT	N/A
N/A	Flare Slope LT (%)	N/A	N/A	Flare Slope RT (%)	0.0
N/A	Flare Traversable LT?	N/A	N/A	Flare Traversable RT?	N/A
N/A	Landing Length (in)	0.0	N/A	DWS Provided?	N/A
N/A	Landing Width (in)	0.0	N/A	DWS Contrast?	N/A
N/A	Landing Slope (%)	0.0	N/A	DWS Length (in)	N/A
N/A	Landing X Slope (%)	0.0	N/A	DWS Full Width?	N/A
N/A	Landing Curb? (Y/N)	N/A	N/A	DWS Offset LT (in)	N/A
N/A	Shared Landing?	N/A	N/A	DWS Offset RT (in)	N/A
N/A	Gutter Ponding?	0.0	N/A	Gutter Slope (%)	N/A
N/A	Gutter Lip Ht (in)	0.0	N/A	Gutter X Slope (%)	N/A
N/A	Painted X Walk1?	No		Road Slope (%)	2.2
	X Walk 1 Direction	To N		Road X Slope (%)	0.5
	X Walk 1 Width (in)	N/A		Clear Space?	N/A

X Walk 1 Slope (%)	2.2	N/A	Clear Space to XWalk (in)	N/A
	X Walk 1 X Slope (%)	0.5	N/A	Storm Grate/Utility Hazard?	N/A
N/A	Ramp inside XWalk1?	N/A		Storm Grate/Utility Type	
N/A	Any Obstructions?	N/A			N/A
	Obstruction Type		Yes	Surface Condition? (G/P)	Good
			N/A	Curb Slope (%)	0.4

Possible Solutions:

**Remove & Replace Entire Ramp.**

PROW/ADA:

**R304.5.3**
