# Access Compliance Report

## Public Rights-of-Way

### (Curb Ramps)

Intersection ID: 48166	Main Street: NORTHLAKE_MALL_DR	Cross Street: NORTHLAKE_CENTRE_PY	Location: NE
ADA ID: 8F53F8D8322D	Ramp Type: Perpendicular	Initial Pass/Fail: Fail	Overall Compliance: No
Severity Score: 21.25			
Codes/Mitigation Info/Possible Solution		Field Measurements/Component Compliance

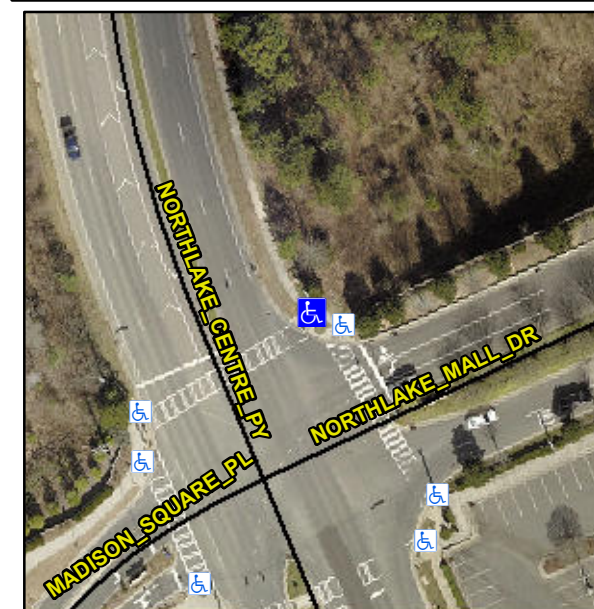
**Not Found, R304.5.1, R304.5.3**

Compliance	Description	Data	Compliance	Description	Data
N/A	Ramp Length (in)	98.0	Yes	Ramp Slope (%)	7.0
No	Ramp Width (in)	46.0	No	Ramp XSlope (%)	5.4
N/A	Flare Type LT	N/A	N/A	Flare Type RT	N/A
N/A	Flare Slope LT (%)	N/A	N/A	Flare Slope RT (%)	N/A
N/A	Flare Traversable LT?	N/A	N/A	Flare Traversable RT?	N/A
N/A	Landing Length (in)	N/A	N/A	DWS Provided?	N/A
N/A	Landing Width (in)	N/A	N/A	DWS Contrast?	N/A
N/A	Landing Slope (%)	N/A	N/A	DWS Length (in)	N/A
N/A	Landing X Slope (%)	N/A	N/A	DWS Full Width?	N/A
N/A	Landing Curb? (Y/N)	N/A	N/A	DWS Offset (in)	N/A
N/A	Shared Landing?	N/A			
N/A	Gutter Ponding?	N/A	N/A	Gutter Slope (%)	N/A
N/A	Gutter Lip Ht (in)	N/A	N/A	Gutter X Slope (%)	N/A
N/A	Painted X Walk1?	Yes	N/A	Painted X Walk2?	N/A
	X Walk 1 Direction	To SW		X Walk 2 Direction	N/A
N/A	X Walk 1 Width (in)	112.0	N/A	X Walk 2 Width (in)	N/A
	X Walk 1 Slope (%)	1.2		X Walk 2 Slope (%)	N/A
	X Walk 1 X Slope (%)	4.5		X Walk 2 X Slope (%)	N/A

N/A	Ramp inside XWalk1?	Yes	N/A	Ramp inside XWalk2?	N/A
	Road Slope (%)	N/A	N/A	Clear Space?	N/A
	Road X Slope (%)	N/A	N/A	Clear Space to XWalk (in)	N/A
N/A	Any Obstructions?	N/A	N/A	Storm Grate/Utility Hazard?	N/A
	Obstruction Type			Storm Grate/Utility Type	
		N/A			N/A
		Yes		Surface Condition? (G/P)	Good

**Remove & Replace Entire Ramp.**

Total Cost: \$ 1850.00
