Access Compliance Report

Public Rights-of-Way

(Curb Ramps)

Intersection ID: 12527	Main Street: E_7TH_ST	Cross Street: N_DAVIDSON_ST	Location: S
ADA ID: 8F5733BDD0AD	Ramp Type: Perpendicular Diagonal	Initial Pass/Fail: Fail	Overall Compliance: No
			Severity Score: 21.25

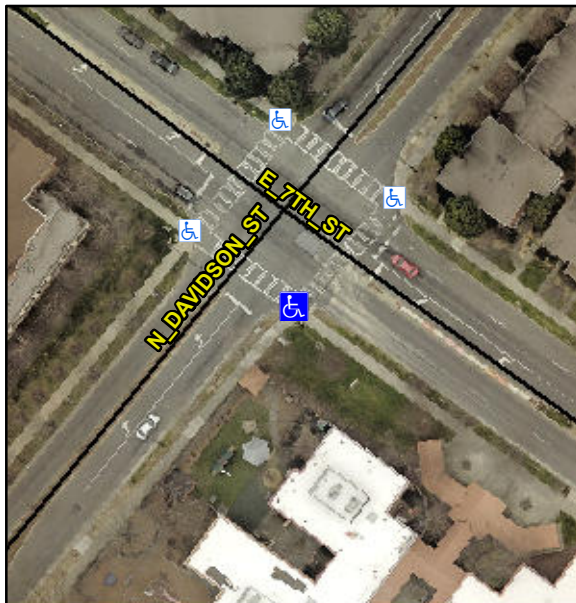
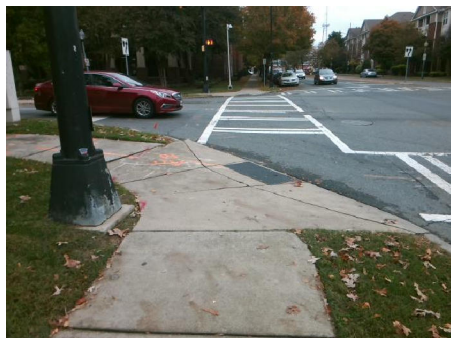
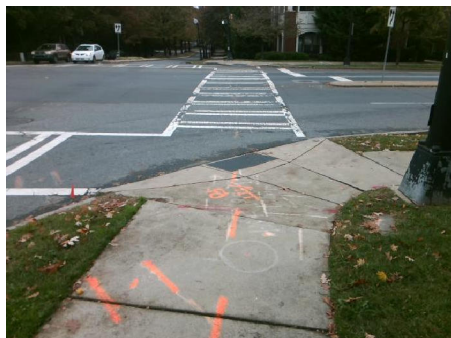
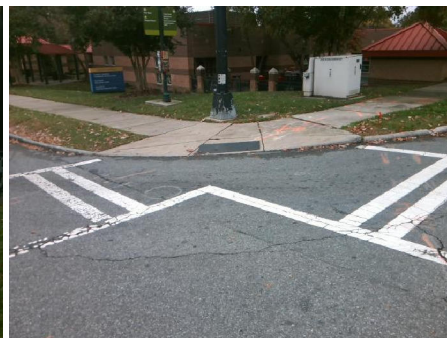
Compliance	Description	Data	Compliance	Description	Data
N/A	Ramp Length (in)	39.0	Yes	Ramp Slope (%)	5.1
No	Ramp Width (in)	45.0	No	Ramp XSlope (%)	6.3
N/A	Flare Type LT	N/A	N/A	Flare Type RT	N/A
N/A	Flare Slope LT (%)	N/A	N/A	Flare Slope RT (%)	N/A
N/A	Flare Traversable LT?	N/A	N/A	Flare Traversable RT?	N/A
N/A	Landing Length (in)	N/A	N/A	DWS Provided?	N/A
N/A	Landing Width (in)	N/A	N/A	DWS Contrast?	N/A
N/A	Landing Slope (%)	N/A	N/A	DWS Length (in)	N/A
N/A	Landing X Slope (%)	N/A	N/A	DWS Full Width?	N/A
N/A	Landing Curb? (Y/N)	N/A	N/A	DWS Offset (in)	N/A
N/A	Shared Landing?	N/A			
N/A	Gutter Ponding?	N/A	N/A	Gutter Slope (%)	N/A
N/A	Gutter Lip Ht (in)	N/A	N/A	Gutter X Slope (%)	N/A
N/A	Painted X Walk1?	Yes	N/A	Painted X Walk2?	Yes
	X Walk 1 Direction	To NE		X Walk 2 Direction	To NW
N/A	X Walk 1 Width (in)	110.5	N/A	X Walk 2 Width (in)	110.5
	X Walk 1 Slope (%)	1.5		X Walk 2 Slope (%)	6.6
	X Walk 1 X Slope (%)	6.4		X Walk 2 X Slope (%)	2.4

N/A	Ramp inside XWalk1?	Yes	N/A	Ramp inside XWalk2?	Yes
	Road Slope (%)	4.8	N/A	Clear Space?	N/A
	Road X Slope (%)	4.6	N/A	Clear Space to XWalk (in)	N/A
N/A	Any Obstructions?	N/A	N/A	Storm Grate/Utility Hazard?	N/A
	Obstruction Type			Storm Grate/Utility Type	
		N/A			N/A
		Yes		Surface Condition? (G/P)	Good

Remove & Replace Curb Ramp With Two New Directional Ramps or Equivalent.
