Access Compliance Report

Public Rights-of-Way

(Curb Ramps)

Intersection ID: 15178	Main Street: DILWORTH_RD_EAST	Cross Street: IDEAL_WY	Location: SE
ADA ID: 8F6A3E6C4F18	Ramp Type: Directional1	Initial Pass/Fail: Fail	Overall Compliance: No
		Severity Score: 25

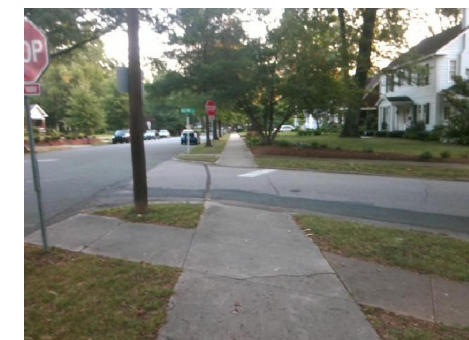
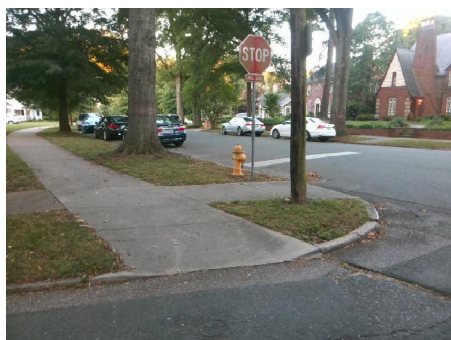
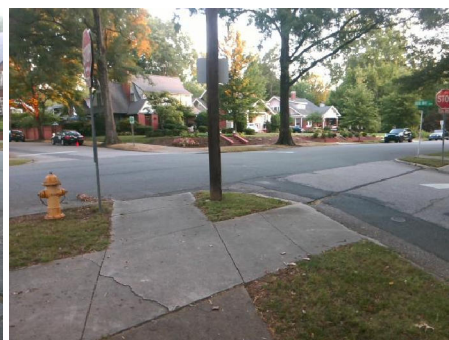
R304.2.2, R304.5.3

Compliance	Description	Data	Compliance	Description	Data
N/A	Ramp Length (in)	88.0	N/A	Grade Break?	N/A
Yes	Ramp Width (in)	48.0	N/A	Grade Break Slope (%)	0.0
No	Ramp Slope (%)	8.9	N/A	Grade Break XSlope (%)	0.0
No	Ramp XSlope (%)	5.8			
N/A	Flare Type LT	N/A	N/A	Flare Type RT	N/A
N/A	Flare Slope LT (%)	N/A	N/A	Flare Slope RT (%)	0.0
N/A	Flare Traversable LT?	N/A	N/A	Flare Traversable RT?	N/A
N/A	Landing Length (in)	0.0	N/A	DWS Provided?	N/A
N/A	Landing Width (in)	0.0	N/A	DWS Contrast?	N/A
N/A	Landing Slope (%)	0.0	N/A	DWS Length (in)	N/A
N/A	Landing X Slope (%)	0.0	N/A	DWS Full Width?	N/A
N/A	Landing Curb? (Y/N)	N/A	N/A	DWS Offset LT (in)	N/A
N/A	Shared Landing?	N/A	N/A	DWS Offset RT (in)	N/A
N/A	Gutter Ponding?	0.0	N/A	Gutter Slope (%)	N/A
N/A	Gutter Lip Ht (in)	0.0	N/A	Gutter X Slope (%)	N/A
N/A	Painted X Walk1?	No		Road Slope (%)	2.0
	X Walk 1 Direction	To N		Road X Slope (%)	1.9
	X Walk 1 Width (in)	N/A		Clear Space?	N/A

X Walk 1 Slope (%)	2.0	N/A	Clear Space to XWalk (in)	N/A
	X Walk 1 X Slope (%)	1.9	N/A	Storm Grate/Utility Hazard?	N/A
N/A	Ramp inside XWalk1?	N/A		Storm Grate/Utility Type	
N/A	Any Obstructions?	N/A			N/A
	Obstruction Type		Yes	Surface Condition? (G/P)	Good
			N/A	Curb Slope (%)	8.0

Remove & Replace Entire Ramp.

Total Cost: \$ 1600.00
