Access Compliance Report

Public Rights-of-Way

(Curb Ramps)

Intersection ID: 10039626	Main Street: THORNTON_RD	Cross Street: N/A	Location: SE
ADA ID: 8F6D74CC1305	Ramp Type: Perpendicular	Initial Pass/Fail: Pass	Overall Compliance: No
Codes/Mitigation Info/Possible Solution		Field Measurements/Component Compliance

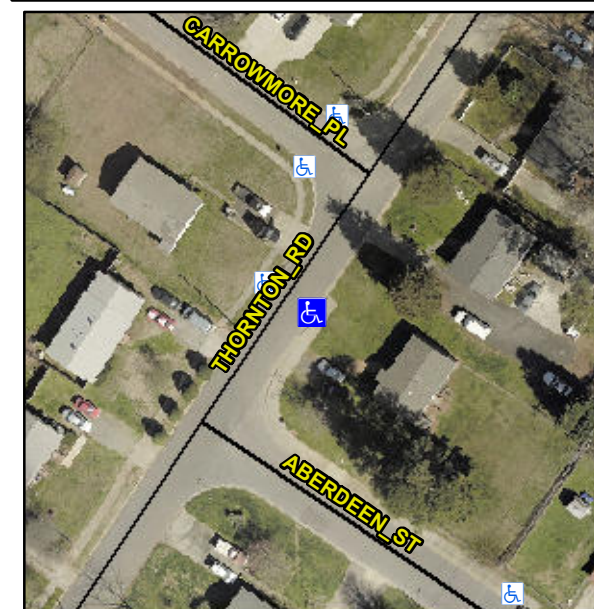
Not Found, R304.2.1, R304.2.2-Perp, R304.3.2-Para, R304.5.3

Compliance	Description	Data	Compliance	Description	Data
N/A	Ramp Length (in)	71.5	Yes	Ramp Slope (%)	5.9
Yes	Ramp Width (in)	48.0	Yes	Ramp XSlope (%)	0.7
N/A	Flare Type LT	Sloped	N/A	Flare Type RT	N/A
N/A	Flare Slope LT (%)	6.4	Yes	Flare Slope RT (%)	3.8
N/A	Flare Traversable LT?	Yes	N/A	Flare Traversable RT?	Yes
No	Landing Length (in)	N/A	Yes	DWS Provided?	Yes
No	Landing Width (in)	N/A	Yes	DWS Contrast?	Yes
No	Landing Slope (%)	N/A	Yes	DWS Length (in)	24.0
No	Landing X Slope (%)	N/A	Yes	DWS Full Width?	Yes
N/A	Landing Curb? (Y/N)	No	Yes	DWS Offset (in)	0.0
N/A	Shared Landing?	No			
Yes	Gutter Ponding?	No	Yes	Gutter Slope (%)	2.6
Yes	Gutter Lip Ht (in)	0.0	Yes	Gutter X Slope (%)	0.3
N/A	Painted X Walk1?	No	N/A	Painted X Walk2?	N/A
	X Walk 1 Direction	To NW		X Walk 2 Direction	N/A
N/A	X Walk 1 Width (in)	N/A	N/A	X Walk 2 Width (in)	N/A
	X Walk 1 Slope (%)	4.2		X Walk 2 Slope (%)	N/A
	X Walk 1 X Slope (%)	0.6		X Walk 2 X Slope (%)	N/A

N/A	Ramp inside XWalk1?	N/A	N/A	Ramp inside XWalk2?	N/A
	Road Slope (%)	N/A	N/A	Clear Space?	Yes
	Road X Slope (%)	N/A	N/A	Clear Space to XWalk (in)	N/A
Yes	Any Obstructions?	No	Yes	Storm Grate/Utility Hazard?	No
	Obstruction Type			Storm Grate/Utility Type	
		N/A			N/A
			Yes	Surface Condition? (G/P)	Good

Remove & Replace Entire Ramp.
