# Access Compliance Report

## Public Rights-of-Way

### (Curb Ramps)

Intersection ID: 29275	Main Street: CHALK_HILL_LN	Cross Street: PAWLEY_DR	Location: SW
ADA ID: 8F7687B8E491	Ramp Type: Perpendicular Diagonal	Initial Pass/Fail: Fail	Overall Compliance: No
		Severity Score: 12.5

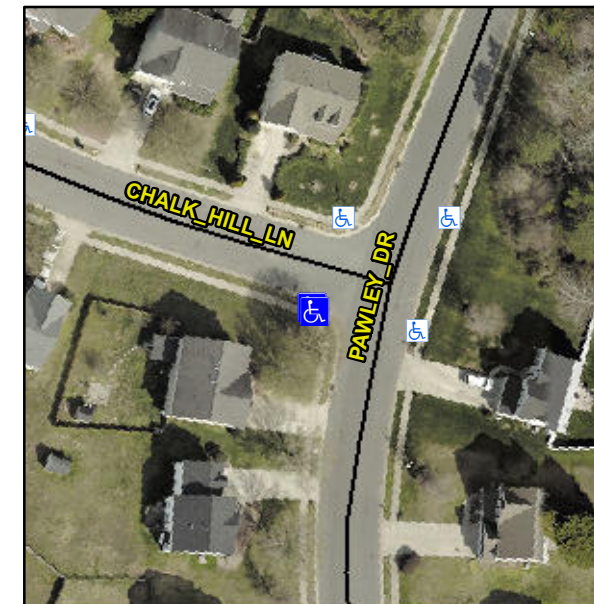
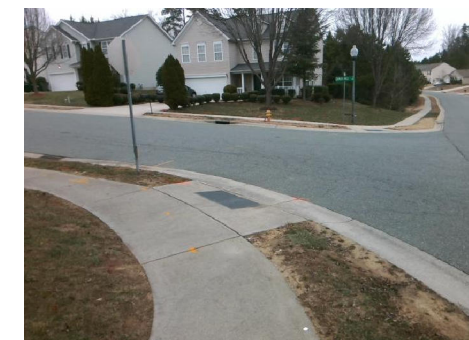
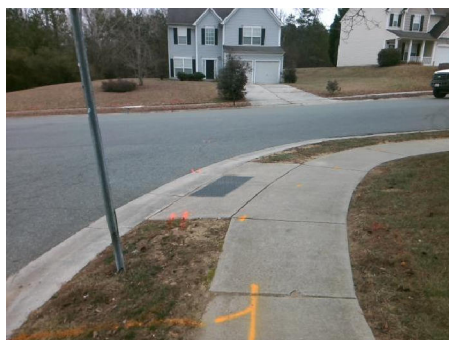
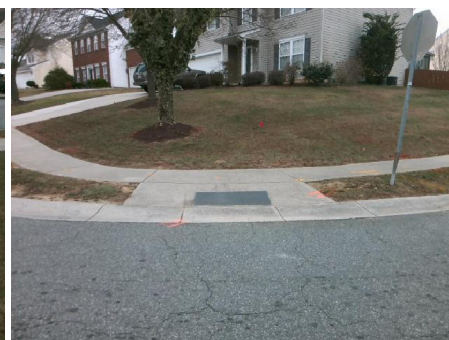
**Not Found, R304.2.2**

Compliance	Description	Data	Compliance	Description	Data
N/A	Ramp Length (in)	45.0	No	Ramp Slope (%)	11.2
Yes	Ramp Width (in)	48.0	Yes	Ramp XSlope (%)	0.4
N/A	Flare Type LT	N/A	N/A	Flare Type RT	N/A
N/A	Flare Slope LT (%)	N/A	N/A	Flare Slope RT (%)	N/A
N/A	Flare Traversable LT?	N/A	N/A	Flare Traversable RT?	N/A
N/A	Landing Length (in)	N/A	N/A	DWS Provided?	N/A
N/A	Landing Width (in)	N/A	N/A	DWS Contrast?	N/A
N/A	Landing Slope (%)	N/A	N/A	DWS Length (in)	N/A
N/A	Landing X Slope (%)	N/A	N/A	DWS Full Width?	N/A
N/A	Landing Curb? (Y/N)	N/A	N/A	DWS Offset (in)	N/A
N/A	Shared Landing?	N/A			
N/A	Gutter Ponding?	N/A	N/A	Gutter Slope (%)	N/A
N/A	Gutter Lip Ht (in)	N/A	N/A	Gutter X Slope (%)	N/A
N/A	Painted X Walk1?	No	N/A	Painted X Walk2?	No
	X Walk 1 Direction	To E		X Walk 2 Direction	To N
N/A	X Walk 1 Width (in)	N/A	N/A	X Walk 2 Width (in)	N/A
	X Walk 1 Slope (%)	1.7		X Walk 2 Slope (%)	3.8
	X Walk 1 X Slope (%)	4.5		X Walk 2 X Slope (%)	1.5

N/A	Ramp inside XWalk1?	N/A	N/A	Ramp inside XWalk2?	N/A
	Road Slope (%)	0.8	N/A	Clear Space?	N/A
	Road X Slope (%)	3.2	N/A	Clear Space to XWalk (in)	N/A
N/A	Any Obstructions?	N/A	N/A	Storm Grate/Utility Hazard?	N/A
	Obstruction Type			Storm Grate/Utility Type	
		N/A			N/A
			Yes	Surface Condition? (G/P)	Good

**Remove & Replace Curb Ramp With Two New Directional Ramps or Equivalent.**
