Access Compliance Report

Public Rights-of-Way

(Curb Ramps)

Intersection ID: N/A	Main Street: GROVER RD	Cross Street: N/A	Location: W
ADA ID: 8F786EF24585	Ramp Type: Perpendicular	Initial Pass/Fail: Fail	Overall Compliance: No
Codes/Mitigation Info/Possible Solution		Field Measurements/Component Compliance	
Severity Score: 12.5

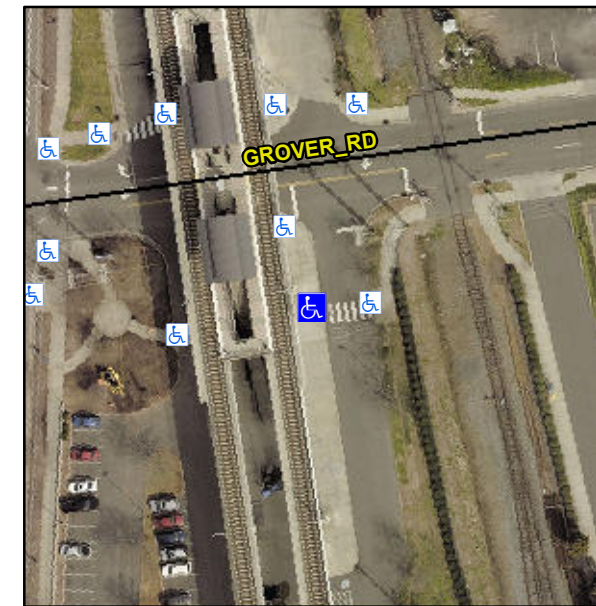
Compliance	Description	Data	Compliance	Description	Data
N/A	Ramp Length (in)	72.0	No	Ramp Slope (%)	11.3
Yes	Ramp Width (in)	49.0	Yes	Ramp XSlope (%)	0.6
N/A	Flare Type LT	N/A	N/A	Flare Type RT	N/A
N/A	Flare Slope LT (%)	N/A	N/A	Flare Slope RT (%)	N/A
N/A	Flare Traversable LT?	No	N/A	Flare Traversable RT?	No
N/A	Landing Length (in)	N/A	N/A	DWS Provided?	N/A
N/A	Landing Width (in)	N/A	N/A	DWS Contrast?	N/A
N/A	Landing Slope (%)	N/A	N/A	DWS Length (in)	N/A
N/A	Landing X Slope (%)	N/A	N/A	DWS Full Width?	N/A
N/A	Landing Curb? (Y/N)	N/A	N/A	DWS Offset (in)	N/A
N/A	Shared Landing?	N/A			
N/A	Gutter Ponding?	N/A	N/A	Gutter Slope (%)	N/A
N/A	Gutter Lip Ht (in)	N/A	N/A	Gutter X Slope (%)	N/A
N/A	Painted X Walk1?	Yes	N/A	Painted X Walk2?	N/A
	X Walk 1 Direction	To E		X Walk 2 Direction	N/A
N/A	X Walk 1 Width (in)	119.0	N/A	X Walk 2 Width (in)	N/A
	X Walk 1 Slope (%)	0.4		X Walk 2 Slope (%)	N/A
	X Walk 1 X Slope (%)	0.9		X Walk 2 X Slope (%)	N/A

N/A	Ramp inside XWalk1?	Yes	N/A	Ramp inside XWalk2?	N/A
	Road Slope (%)	N/A	N/A	Clear Space?	N/A
	Road X Slope (%)	N/A	N/A	Clear Space to XWalk (in)	N/A
N/A	Any Obstructions?	N/A	N/A	Storm Grate/Utility Hazard?	N/A
	Obstruction Type			Storm Grate/Utility Type	
		N/A			N/A
		Yes		Surface Condition? (G/P)	Good

Possible Solutions:

Remove & Replace Entire Ramp.
