# Access Compliance Report

## Public Rights-of-Way

### (Curb Ramps)

Intersection ID: 13618	Main Street: S_CALDWELL_ST	Cross Street: TEMPLETON_AV	Location: E
ADA ID: 8F8F34A52591	Ramp Type: Directional1	Initial Pass/Fail: Fail	Overall Compliance: No
Severity Score: 1.25			
Codes/Mitigation Info/Possible Solution		Field Measurements/Component Compliance

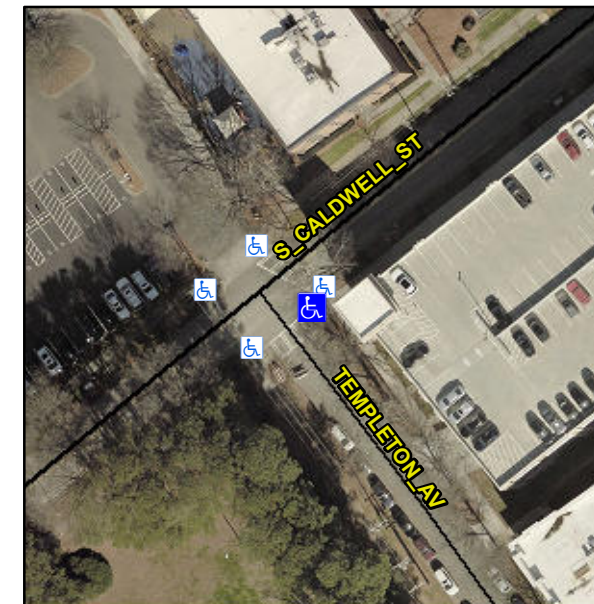
Compliance	Description	Data	Compliance	Description	Data
N/A	Ramp Length (in)	69.0	N/A	Grade Break?	N/A
Yes	Ramp Width (in)	81.0	N/A	Grade Break Slope (%)	0.0
Yes	Ramp Slope (%)	7.5	N/A	Grade Break XSlope (%)	0.0
No	Ramp XSlope (%)	2.4			
N/A	Flare Type LT	N/A	N/A	Flare Type RT	N/A
N/A	Flare Slope LT (%)	N/A	N/A	Flare Slope RT (%)	0.0
N/A	Flare Traversable LT?	N/A	N/A	Flare Traversable RT?	N/A
N/A	Landing Length (in)	0.0	N/A	DWS Provided?	N/A
N/A	Landing Width (in)	0.0	N/A	DWS Contrast?	N/A
N/A	Landing Slope (%)	0.0	N/A	DWS Length (in)	N/A
N/A	Landing X Slope (%)	0.0	N/A	DWS Full Width?	N/A
N/A	Landing Curb? (Y/N)	N/A	N/A	DWS Offset LT (in)	N/A
N/A	Shared Landing?	N/A	N/A	DWS Offset RT (in)	N/A
N/A	Gutter Ponding?	0.0	N/A	Gutter Slope (%)	N/A
N/A	Gutter Lip Ht (in)	0.0	N/A	Gutter X Slope (%)	N/A
N/A	Painted X Walk1?	Yes		Road Slope (%)	0.2
	X Walk 1 Direction	To SW		Road X Slope (%)	0.3
	X Walk 1 Width (in)	112.0		Clear Space?	N/A

X Walk 1 Slope (%)	0.2	N/A	Clear Space to XWalk (in)	N/A
	X Walk 1 X Slope (%)	0.3	N/A	Storm Grate/Utility Hazard?	N/A
N/A	Ramp inside XWalk1?	Yes		Storm Grate/Utility Type	
N/A	Any Obstructions?	N/A			N/A
	Obstruction Type		Yes	Surface Condition? (G/P)	Good
			N/A	Curb Slope (%)	8.9

**Remove & Replace Entire Ramp.**

**R304.5.3**
