# Access Compliance Report

## Public Rights-of-Way

### (Curb Ramps)

| Intersection ID: 47837 | Main Street: CACTUS_VALLEY_RD | Cross Street: DRAGONFLY_LN | Location: NW |

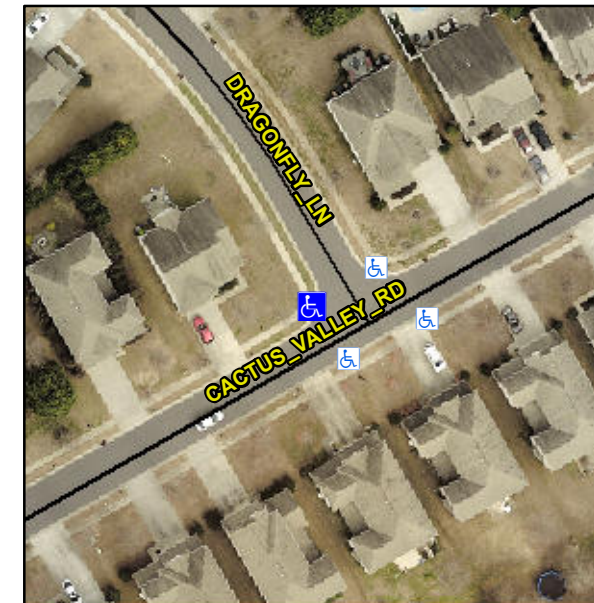
| ADA ID: 8F96CDAEBB01 | Ramp Type: PerpDiag | Initial Pass/Fail: Fail | Overall Compliance: No |

**Not Found, R304.5.1, R304.2.2**

| Compliance | Description | Data | Compliance | Description | Data |
|---|---|---|---|---|---|
| N/A | Ramp Length (in) | 45.0 | No | Ramp Slope (%) | 9.1 |
| No | Ramp Width (in) | 45.0 | Yes | Ramp XSlope (%) | 1.0 |

**Remove & Replace Curb Ramp With Two New Directional Ramps or Equivalent.**

Total Cost: \$ 3200.00
