Access Compliance Report Public Rights-of-Way (Curb Ramps)

Intersection ID: 18381 Main Street: BATHURST DR **Cross Street: WYALONG DR** Location: SE **ADA ID: 8F9E64EBC7E3** Ramp Type: BlendTrans1 Initial Pass/Fail: Pass **Overall Compliance: No Severity Score:**

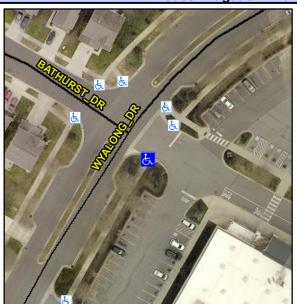
11//	riare Type Er	Ciopca	14/7	riare rypertr	Olopea
N/A	Flare Slope LT (%)	3.3	N/A	Flare Slope RT (%)	5.0
N/A	Flare Traversable LT?	No	N/A	Flare Traversable RT?	No
Yes	Landing Length (in)	53.0	Yes	DWS Provided?	Yes
Yes	Landing Width (in)	48.0	Yes	DWS Contrast?	Yes
No	Landing Slope (%)	2.5	Yes	DWS Length (in)	24.5
Yes	Landing X Slope (%)	1.6	Yes	DWS Full Width?	Yes
N/A	Landing Curb? (Y/N)	No	Yes	DWS Offset (in)	0.0
N/A	Shared Landing?	No			
Yes	Gutter Ponding?	No	Yes	Gutter Slope (%)	2.2
Yes	Gutter Lip Ht (in)	0.0	Yes	Gutter X Slope (%)	1.6
N/A	Painted X Walk1?	No	N/A	Painted X Walk2?	N/A
	X Walk 1 Direction	To NE		X Walk 2 Direction	N/A
	X Walk 1 Width (in)	N/A		X Walk 2 Width (in)	N/A
	X Walk 1 Slope (%)	1.1		X Walk 2 Slope (%)	N/A
	X Walk 1 X Slope (%)	0.7		X Walk 2 X Slope (%)	N/A
N/A	Ramp inside XWalk1?	N/A	N/A	Ramp inside XWalk2?	N/A
	Road Slope (%)	0.7		Clear Space?	Yes
	Road X Slope (%)	1.1	N/A	Clear Space to XWalk (in)	N/A

Yes	Any Obstructions?	No	Yes	Storm Grate/Utility Hazard?	No
	Obstruction Type			Storm Grate/Utility Type	
		N/A			N/A
			Yes	Surface Condition? (G/P)	Good

Possible Solutions: Compliance Description Remove & Replace Landing. N/A Yes N/A Surveyor Notes: N/A PROW/ADA: R304.2.2-Perp, R304.3.2-Para
