Access Compliance Report

Public Rights-of-Way

(Curb Ramps)

Intersection ID: N/A	Main Street: PHILLIPS_AV	Cross Street: MAYFLOWER_RD	Location: NW
ADA ID: 8FA0E12DEAD5	Ramp Type: Directional1	Initial Pass/Fail: Pass	Overall Compliance: No
		Severity Score: 2.5

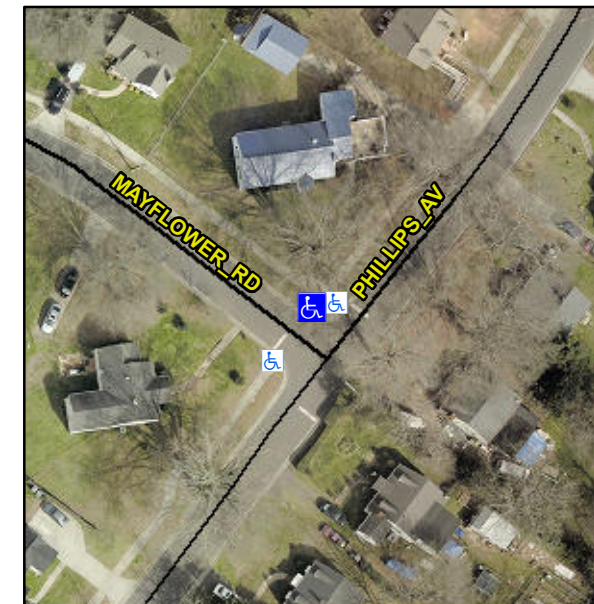
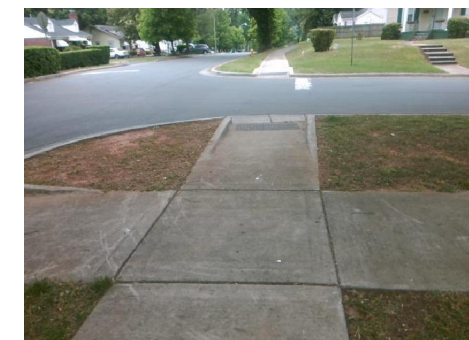
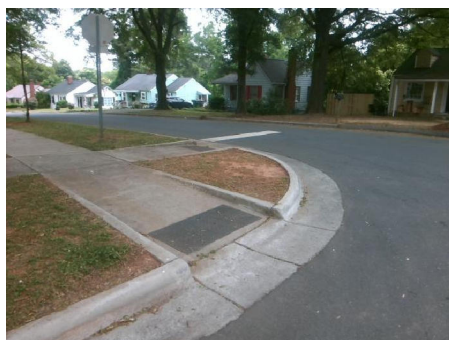
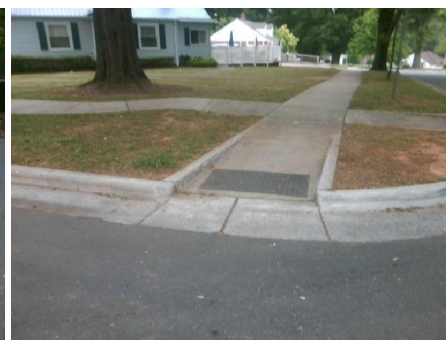
R304.5.3, R305.1.4, R305.2

Compliance	Description	Data	Compliance	Description	Data
N/A	Ramp Length (in)	136.0	Yes	Grade Break?	Yes
Yes	Ramp Width (in)	54.0	No	Grade Break Slope (%)	11.9
Yes	Ramp Slope (%)	5.4	Yes	Grade Break XSlope (%)	1.9
Yes	Ramp XSlope (%)	1.9			
Yes	Flare Type LT	N/A	Yes	Flare Type RT	N/A
N/A	Flare Slope LT (%)	N/A	N/A	Flare Slope RT (%)	N/A
N/A	Flare Traversable LT?	No	N/A	Flare Traversable RT?	No
Yes	Landing Length (in)	59.0	Yes	DWS Provided?	Yes
Yes	Landing Width (in)	59.0	Yes	DWS Contrast?	Yes
Yes	Landing Slope (%)	0.4	Yes	DWS Length (in)	24.0
Yes	Landing X Slope (%)	1.1	No	DWS Full Width?	No
N/A	Landing Curb? (Y/N)	N/A	Yes	DWS Offset LT (in)	5.0
N/A	Shared Landing?	Yes	No	DWS Offset RT (in)	2.5
Yes	Gutter Ponding?	No	Yes	Gutter Slope (%)	0.4
Yes	Gutter Lip Ht (in)	0.0	Yes	Gutter X Slope (%)	1.7
N/A	Painted X Walk1?	No		Road Slope (%)	0.4
	X Walk 1 Direction	To S		Road X Slope (%)	1.4
	X Walk 1 Width (in)	N/A		Clear Space?	Yes

X Walk 1 Slope (%)	0.4	N/A	Clear Space to XWalk (in)	N/A
	X Walk 1 X Slope (%)	1.4	Yes	Storm Grate/Utility Hazard?	No
N/A	Ramp inside XWalk1?	N/A		Storm Grate/Utility Type	
Yes	Any Obstructions?	No			N/A
	Obstruction Type		Yes	Surface Condition? (G/P)	Good
			N/A	Curb Slope (%)	4.7

Possible Solutions:

Remove & Replace Entire Ramp.

Total Cost: \$ 1600.00
