Access Compliance Report Public Rights-of-Way (Curb Ramps)

Intersection ID: 49008Main Street:FARM_LNCross Street:STEELECROFT_PYLocation:NEADA ID: 8FA7E48E8C4CRamp Type:BlendTrans1Initial Pass/Fail:FailOverall Compliance:NoSeverity Score:10

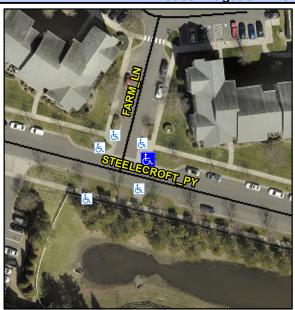
Street 1 Name
STEELECROFT PY
Stop Condition-Street 1
None
Street 2 Name
N/A
Stop Condition-Street 2
N/A

Not Found, R304.5.1

Compilation Description		Dutu	- Compliance Description		Dutu
N/A	Ramp Length (in)	82.0	Yes	BlendTrans Slope (%)	2.8
No	Ramp Width (in)	46.5	Yes	BlendTrans XSlope (%)	2.9
N/A	Flare Type LT	N/A	N/A	Flare Type RT	N/A
N/A	Flare Slope LT (%)	N/A	N/A	Flare Slope RT (%)	N/A
N/A	Flare Traversable LT?	N/A	N/A	Flare Traversable RT?	N/A
N/A	Landing Length (in)	N/A	N/A	DWS Provided?	N/A
N/A	Landing Width (in)	N/A	N/A	DWS Contrast?	N/A
N/A	Landing Slope (%)	N/A	N/A	DWS Length (in)	N/A
N/A	Landing X Slope (%)	N/A	N/A	DWS Full Width?	N/A
N/A	Landing Curb? (Y/N)	N/A	N/A	DWS Offset (in)	N/A
N/A	Shared Landing?	N/A			
N/A	Gutter Ponding?	N/A	N/A	Gutter Slope (%)	N/A
N/A	Gutter Lip Ht (in)	N/A	N/A	Gutter X Slope (%)	N/A
N/A	Painted X Walk1?	No	N/A	Painted X Walk2?	N/A
	X Walk 1 Direction	To S		X Walk 2 Direction	N/A
	X Walk 1 Width (in)	N/A		X Walk 2 Width (in)	N/A
	X Walk 1 Slope (%)	1.7		X Walk 2 Slope (%)	N/A
	X Walk 1 X Slope (%)	3.4		X Walk 2 X Slope (%)	N/A

N/A	Ramp inside XWalk1?	N/A	N/A	Ramp inside XWalk2?	N/A
	Road Slope (%)	3.4		Clear Space?	N/A
	Road X Slope (%)	1.7	N/A	Clear Space to XWalk (in)	N/A
N/A	Any Obstructions?	N/A	N/A	Storm Grate/Utility Hazard?	N/A
	Obstruction Type			Storm Grate/Utility Type	
		N/A			N/A
			Yes	Surface Condition? (G/P)	Good
3,48			No	Curb Slope (%)	10.5

Remove & Replace Curb Ramp With Two New Directional Ramps or Equivalent.

3200.00
