# Access Compliance Report

## Public Rights-of-Way

| Intersection ID: 47087 | Main Street: MARVIN_RD | Cross Street: COVENTRY_COURT_LN | Location: E |
| ADA ID: 8FB707AF3AC9 | Ramp Type: PerpDiag | Initial Pass/Fail: Fail | Overall Compliance: No |

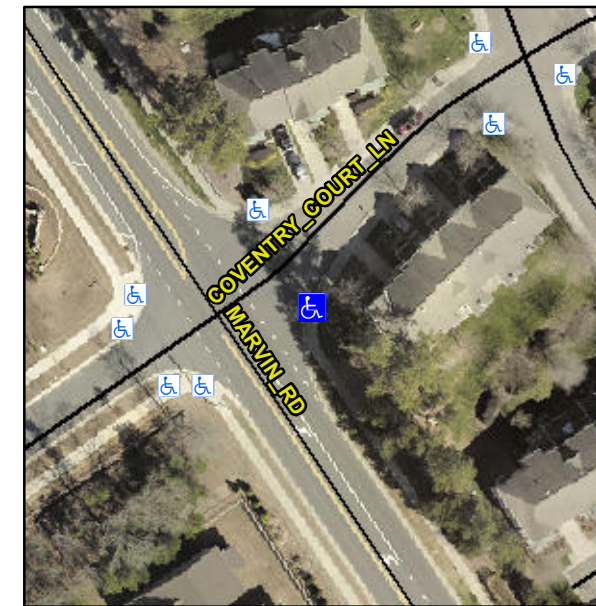
| Severity Score: 12.5 | | | |

**Not Found, R304.2.2**

| Compliance | Description | Data | Compliance | Description | Data |
|---|---|---|---|---|---|
| N/A | Ramp Length (in) | 61.0 | No | Ramp Slope (%) | 9.1 |

**Remove & Replace Curb Ramp With Two New Directional Ramps or Equivalent.**

Total Cost: \$ 3200.00
