Access Compliance Report

Public Rights-of-Way

(Curb Ramps)

Intersection ID: 3088	Main Street: DEARMON_RD	Cross Street: MINERAL_RIDGE_WY	Location: E
ADA ID: 8FBAACBACEDD	Ramp Type: Perp	Initial Pass/Fail: Fail	Overall Compliance: No
Severity Score: 36.25			
Codes/Mitigation Info/Possible Solution		Field Measurements/Component Compliance

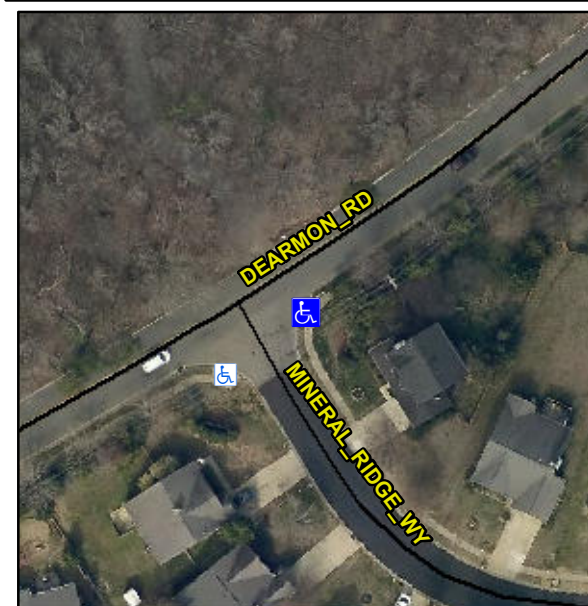
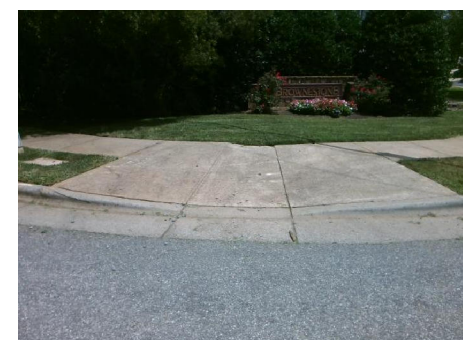
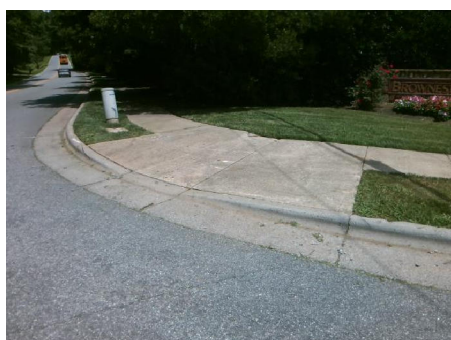
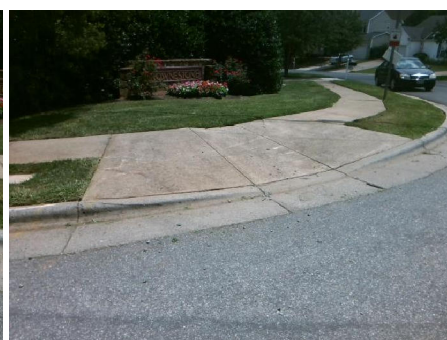
Not Found, R304.5.1, R304.5.3

Compliance	Description	Data	Compliance	Description	Data
N/A	Ramp Length (in)	97.5	Yes	Ramp Slope (%)	5.1
No	Ramp Width (in)	31.5	No	Ramp XSlope (%)	2.2
N/A	Flare Type LT	N/A	N/A	Flare Type RT	N/A
N/A	Flare Slope LT (%)	N/A	N/A	Flare Slope RT (%)	N/A
N/A	Flare Traversable LT?	N/A	N/A	Flare Traversable RT?	N/A
N/A	Landing Length (in)	N/A	N/A	DWS Provided?	N/A
N/A	Landing Width (in)	N/A	N/A	DWS Contrast?	N/A
N/A	Landing Slope (%)	N/A	N/A	DWS Length (in)	N/A
N/A	Landing X Slope (%)	N/A	N/A	DWS Full Width?	N/A
N/A	Landing Curb? (Y/N)	N/A	N/A	DWS Offset (in)	N/A
N/A	Shared Landing?	N/A			
N/A	Gutter Ponding?	N/A	N/A	Gutter Slope (%)	N/A
N/A	Gutter Lip Ht (in)	N/A	N/A	Gutter X Slope (%)	N/A
N/A	Painted X Walk1?	No	N/A	Painted X Walk2?	N/A
	X Walk 1 Direction	To SW		X Walk 2 Direction	N/A
N/A	X Walk 1 Width (in)	N/A	N/A	X Walk 2 Width (in)	N/A
	X Walk 1 Slope (%)	5.4		X Walk 2 Slope (%)	N/A
	X Walk 1 X Slope (%)	4.6		X Walk 2 X Slope (%)	N/A

N/A	Ramp inside XWalk1?	N/A	N/A	Ramp inside XWalk2?	N/A
	Road Slope (%)	N/A	N/A	Clear Space?	N/A
	Road X Slope (%)	N/A	N/A	Clear Space to XWalk (in)	N/A
N/A	Any Obstructions?	N/A	N/A	Storm Grate/Utility Hazard?	N/A
	Obstruction Type			Storm Grate/Utility Type	
		N/A			N/A
			Yes	Surface Condition? (G/P)	Good

Remove & Replace Entire Ramp.

Total Cost: \$ 1850.00
