Access Compliance Report

Public Rights-of-Way

(Curb Ramps)

Intersection ID: 10023519	Main Street: CLANTON_RD	Cross Street: N/A	Location: E
ADA ID: 8FBC0B5BD7D6	Ramp Type: BlendTrans1	Initial Pass/Fail: Pass	Overall Compliance: Yes
Severity Score: 0			
Codes/Mitigation Info/Possible Solution		Field Measurements/Component Compliance

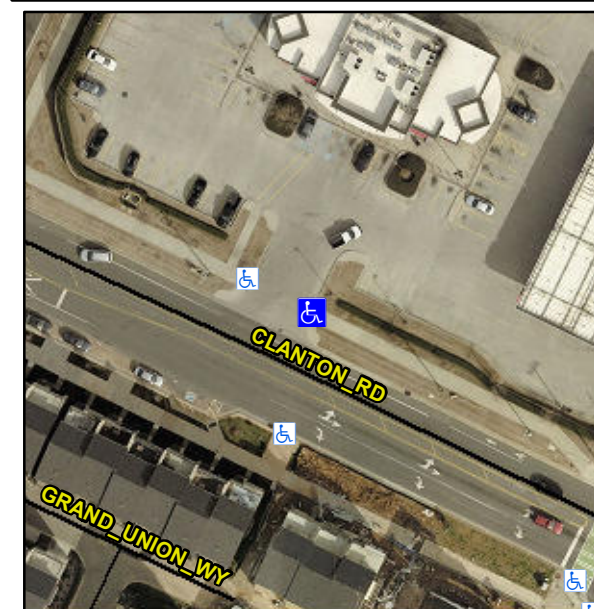
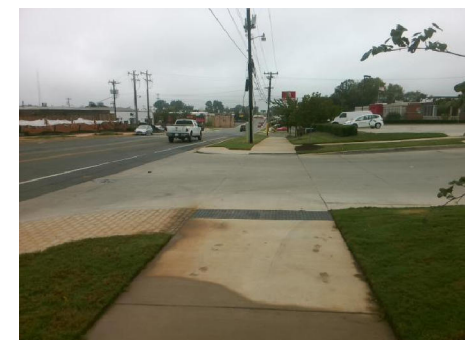
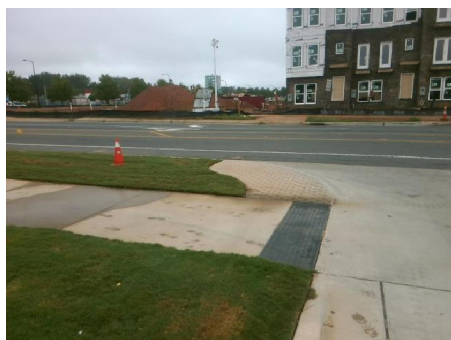
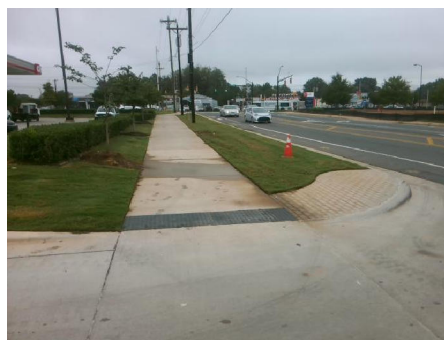
NO CURB LINE

Compliance	Description	Data	Compliance	Description	Data
N/A	Ramp Length (in)	134.0	Yes	BlendTrans Slope (%)	3.1
Yes	Ramp Width (in)	96.0	Yes	BlendTrans XSlope (%)	0.1
N/A	Flare Type LT	None	N/A	Flare Type RT	None
N/A	Flare Slope LT (%)	N/A	N/A	Flare Slope RT (%)	N/A
N/A	Flare Traversable LT?	N/A	N/A	Flare Traversable RT?	N/A
Yes	Landing Length (in)	103.0	Yes	DWS Provided?	Yes
Yes	Landing Width (in)	96.0	Yes	DWS Contrast?	Yes
Yes	Landing Slope (%)	1.6	Yes	DWS Length (in)	24.0
Yes	Landing X Slope (%)	0.5	Yes	DWS Full Width?	Yes
N/A	Landing Curb? (Y/N)	No	Yes	DWS Offset (in)	0.0
N/A	Shared Landing?	No			
Yes	Gutter Ponding?	No	Yes	Gutter Slope (%)	1.6
Yes	Gutter Lip Ht (in)	0.0	Yes	Gutter X Slope (%)	2.2
N/A	Painted X Walk1?	No	N/A	Painted X Walk2?	N/A
	X Walk 1 Direction	To NW		X Walk 2 Direction	N/A
	X Walk 1 Width (in)	N/A		X Walk 2 Width (in)	N/A
	X Walk 1 Slope (%)	1.6		X Walk 2 Slope (%)	N/A
	X Walk 1 X Slope (%)	2.2		X Walk 2 X Slope (%)	N/A

N/A	Ramp inside XWalk1?	N/A	N/A	Ramp inside XWalk2?	N/A
	Road Slope (%)	2.2		Clear Space?	Yes
	Road X Slope (%)	1.6	N/A	Clear Space to XWalk (in)	N/A
Yes	Any Obstructions?	No	Yes	Storm Grate/Utility Hazard?	No
	Obstruction Type			Storm Grate/Utility Type	
			N/A		N/A
			Yes	Surface Condition? (G/P)	Good
			N/A	Curb Slope (%)	N/A
