Access Compliance Report

Public Rights-of-Way

(Curb Ramps)

Intersection ID: 28969	Main Street: HERON_GLEN_DR	Cross Street: KESTRAL_RIDGE_DR	Location:	N
ADA ID: 8FC816CB6CC6	Ramp Type: BlendTrans1	Initial Pass/Fail: Fail	Overall Compliance: No	Severity Score: 10

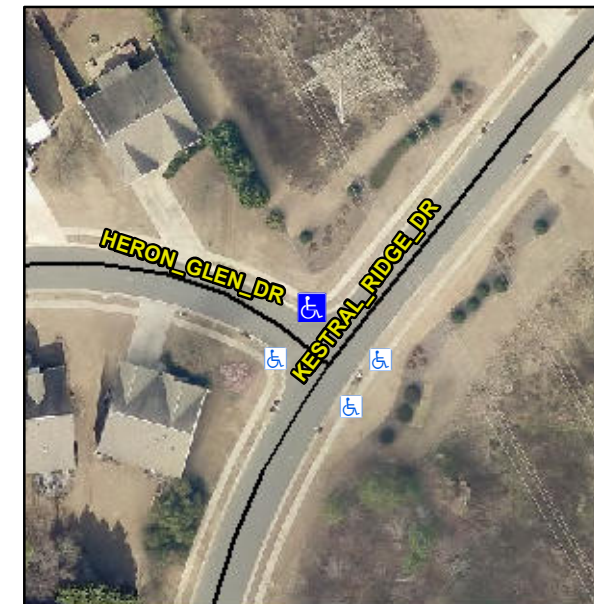
Compliance	Description	Data	Compliance	Description	Data
N/A	Ramp Length (in)	49.0	Yes	BlendTrans Slope (%)	2.7
No	Ramp Width (in)	47.0	No	BlendTrans XSlope (%)	2.8
N/A	Flare Type LT	N/A	N/A	Flare Type RT	N/A
N/A	Flare Slope LT (%)	N/A	N/A	Flare Slope RT (%)	N/A
N/A	Flare Traversable LT?	N/A	N/A	Flare Traversable RT?	N/A
N/A	Landing Length (in)	N/A	N/A	DWS Provided?	N/A
N/A	Landing Width (in)	N/A	N/A	DWS Contrast?	N/A
N/A	Landing Slope (%)	N/A	N/A	DWS Length (in)	N/A
N/A	Landing X Slope (%)	N/A	N/A	DWS Full Width?	N/A
N/A	Landing Curb? (Y/N)	N/A	N/A	DWS Offset (in)	N/A
N/A	Shared Landing?	N/A			
N/A	Gutter Ponding?	N/A	N/A	Gutter Slope (%)	N/A
N/A	Gutter Lip Ht (in)	N/A	N/A	Gutter X Slope (%)	N/A
N/A	Painted X Walk1?	No	N/A	Painted X Walk2?	No
	X Walk 1 Direction	To SW		X Walk 2 Direction	To SE
	X Walk 1 Width (in)	N/A		X Walk 2 Width (in)	N/A
	X Walk 1 Slope (%)	2.1		X Walk 2 Slope (%)	3.3
	X Walk 1 X Slope (%)	2.5		X Walk 2 X Slope (%)	2.3

N/A	Ramp inside XWalk1?	N/A	N/A	Ramp inside XWalk2?	N/A
	Road Slope (%)	2.4		Clear Space?	N/A
	Road X Slope (%)	2.0	N/A	Clear Space to XWalk (in)	N/A
N/A	Any Obstructions?	N/A	N/A	Storm Grate/Utility Hazard?	N/A
	Obstruction Type			Storm Grate/Utility Type	
		N/A			N/A
			Yes	Surface Condition? (G/P)	Good
			N/A	Curb Slope (%)	4.8

Possible Solutions:

Remove & Replace Curb Ramp With Two New Directional Ramps or Equivalent.

R304.5.1, R304.5.3
