Access Compliance Report

Public Rights-of-Way

(Curb Ramps)

Intersection ID: 30154	Main Street: ALSTON_HILL_DR	Cross Street: RED_BUD_CR	Location: SE
ADA ID: 8FC915E7815C	Ramp Type: BlendTrans1	Initial Pass/Fail: Fail	Overall Compliance: No
		Severity Score: 10

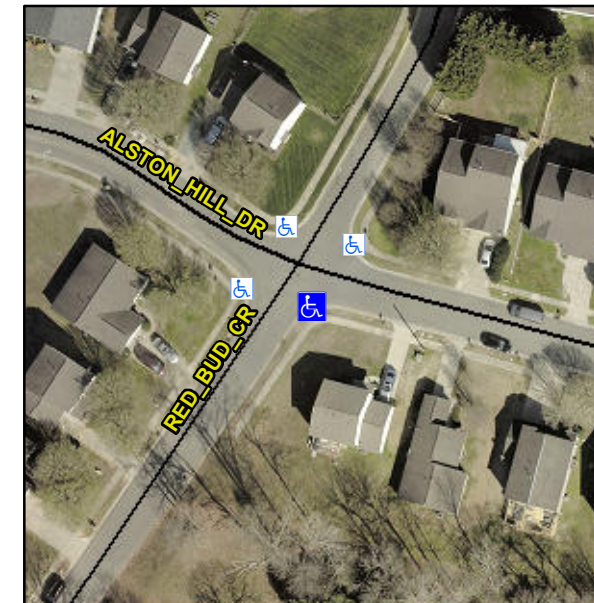
Not Found, R304.5.1, R304.5.3

Compliance	Description	Data	Compliance	Description	Data
N/A	Ramp Length (in)	39.0	Yes	BlendTrans Slope (%)	3.7
No	Ramp Width (in)	47.0	No	BlendTrans XSlope (%)	4.8
N/A	Flare Type LT	N/A	N/A	Flare Type RT	N/A
N/A	Flare Slope LT (%)	N/A	N/A	Flare Slope RT (%)	N/A
N/A	Flare Traversable LT?	N/A	N/A	Flare Traversable RT?	N/A
N/A	Landing Length (in)	N/A	N/A	DWS Provided?	N/A
N/A	Landing Width (in)	N/A	N/A	DWS Contrast?	N/A
N/A	Landing Slope (%)	N/A	N/A	DWS Length (in)	N/A
N/A	Landing X Slope (%)	N/A	N/A	DWS Full Width?	N/A
N/A	Landing Curb? (Y/N)	N/A	N/A	DWS Offset (in)	N/A
N/A	Shared Landing?	N/A			
N/A	Gutter Ponding?	Yes	N/A	Gutter Slope (%)	N/A
N/A	Gutter Lip Ht (in)	N/A	N/A	Gutter X Slope (%)	N/A
N/A	Painted X Walk1?	No	N/A	Painted X Walk2?	No
	X Walk 1 Direction	To NE		X Walk 2 Direction	To W
	X Walk 1 Width (in)	N/A		X Walk 2 Width (in)	N/A
	X Walk 1 Slope (%)	1.3		X Walk 2 Slope (%)	2.5
	X Walk 1 X Slope (%)	5.5		X Walk 2 X Slope (%)	1.3

N/A	Ramp inside XWalk1?	N/A	N/A	Ramp inside XWalk2?	N/A
	Road Slope (%)	2.9		Clear Space?	N/A
	Road X Slope (%)	2.4	N/A	Clear Space to XWalk (in)	N/A
N/A	Any Obstructions?	N/A	N/A	Storm Grate/Utility Hazard?	N/A
	Obstruction Type			Storm Grate/Utility Type	
		N/A			N/A
			Yes	Surface Condition? (G/P)	Good
			No	Curb Slope (%)	11.7

Remove & Replace Curb Ramp With Two New Directional Ramps or Equivalent.
