# Access Compliance Report

## Public Rights-of-Way

| Intersection ID: 50511 | Main Street: ALLEN_A_BROWN_RD | Cross Street: MERIDALE_CROSSING_DR | Location: | N |
| ADA ID: 8FC9CE5256EB | Ramp Type: PerpDiag | Initial Pass/Fail: Fail | Overall Compliance: No | Severity Score: 10 |

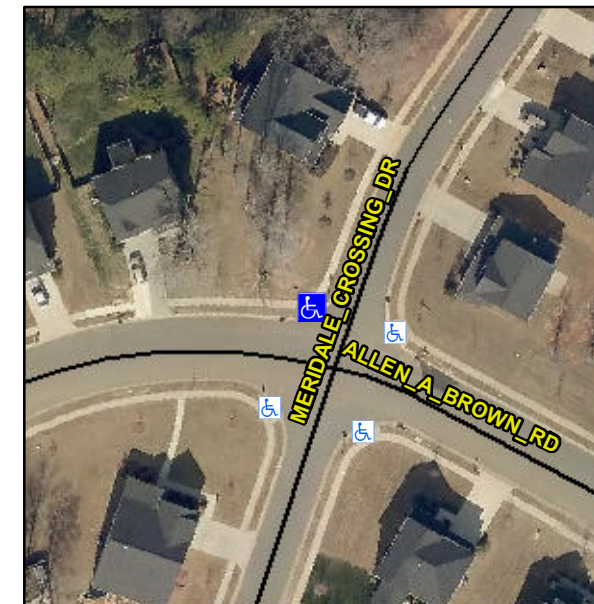
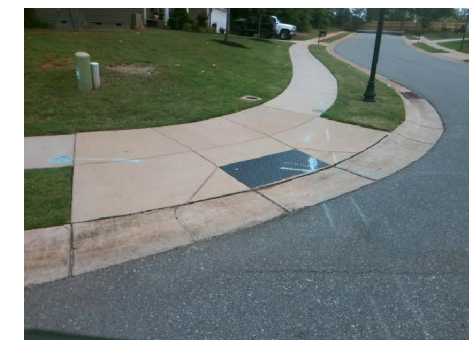
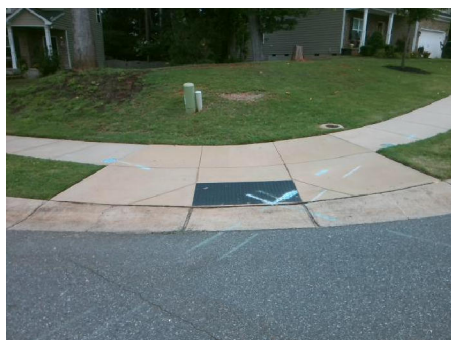
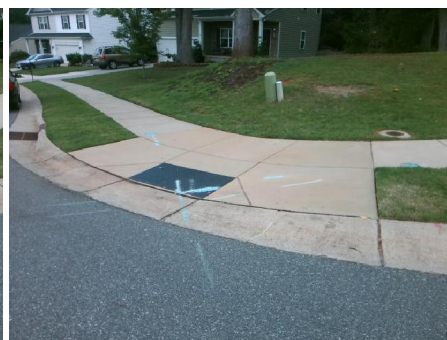
| Compliance | Description | Data | Compliance | Description | Data |
|---|---|---|---|---|---|
| N/A | Ramp Length (in) | 47.5 | Yes | Ramp Slope (%) | 7.8 |
| No | Ramp Width (in) | 47.0 | No | Ramp XSlope (%) | 3.8 |

**Remove & Replace Curb Ramp With Two New Directional Ramps or Equivalent.**

**R304.5.1, R304.5.3**
