Access Compliance Report

Public Rights-of-Way

(Curb Ramps)

Intersection ID: 32270	Main Street: SPRINGWELL_ST	Cross Street: LANCASTER_HY	Location: S
ADA ID: 8FD915D83688	Ramp Type: PerpDiag	Initial Pass/Fail: Fail	Overall Compliance: No
			Severity Score: 21.25

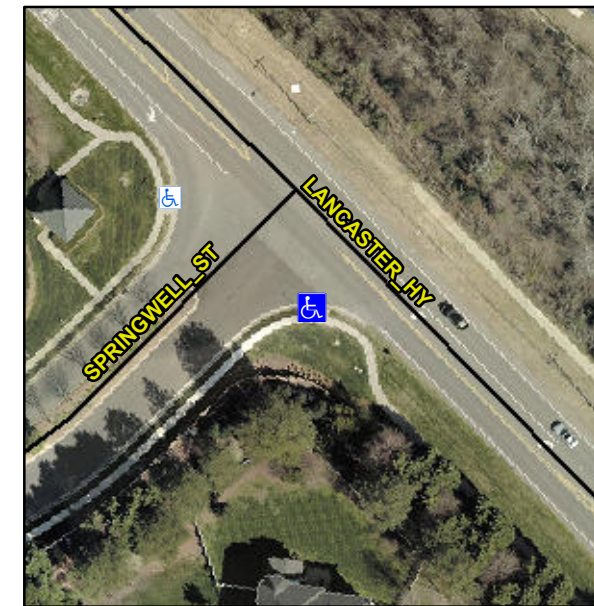
Not Found, R304.5.1, R304.2.2

Compliance	Description	Data	Compliance	Description	Data
N/A	Ramp Length (in)	48.0	No	Ramp Slope (%)	11.1
No	Ramp Width (in)	43.0	Yes	Ramp XSlope (%)	1.3
N/A	Flare Type LT	N/A	N/A	Flare Type RT	N/A
N/A	Flare Slope LT (%)	N/A	N/A	Flare Slope RT (%)	N/A
N/A	Flare Traversable LT?	N/A	N/A	Flare Traversable RT?	N/A
N/A	Landing Length (in)	N/A	N/A	DWS Provided?	N/A
N/A	Landing Width (in)	N/A	N/A	DWS Contrast?	N/A
N/A	Landing Slope (%)	N/A	N/A	DWS Length (in)	N/A
N/A	Landing X Slope (%)	N/A	N/A	DWS Full Width?	N/A
N/A	Landing Curb? (Y/N)	N/A	N/A	DWS Offset (in)	N/A
N/A	Shared Landing?	N/A			
N/A	Gutter Ponding?	N/A	N/A	Gutter Slope (%)	N/A
N/A	Gutter Lip Ht (in)	N/A	N/A	Gutter X Slope (%)	N/A
N/A	Painted X Walk1?	No	N/A	Painted X Walk2?	No
	X Walk 1 Direction	To NE		X Walk 2 Direction	To NW
N/A	X Walk 1 Width (in)	N/A	N/A	X Walk 2 Width (in)	N/A
	X Walk 1 Slope (%)	1.2		X Walk 2 Slope (%)	2.5
	X Walk 1 X Slope (%)	3.9		X Walk 2 X Slope (%)	0.8

N/A	Ramp inside XWalk1?	N/A	N/A	Ramp inside XWalk2?	N/A
	Road Slope (%)	3.4	N/A	Clear Space?	N/A
	Road X Slope (%)	1.9	N/A	Clear Space to XWalk (in)	N/A
N/A	Any Obstructions?	N/A	N/A	Storm Grate/Utility Hazard?	N/A
	Obstruction Type			Storm Grate/Utility Type	
		N/A			N/A
			Yes	Surface Condition? (G/P)	Good

Remove & Replace Curb Ramp With Two New Directional Ramps or Equivalent.
