# Access Compliance Report

## Public Rights-of-Way

### (Curb Ramps)

Intersection ID: 26051	Main Street: BANNINGTON_RD	Cross Street: POPPY_HILLS_LN	Location: SE
ADA ID: 8FDEDD1D47B4	Ramp Type: PerpDiag	Initial Pass/Fail: Fail	Overall Compliance: No
Severity Score: 13.75			
Codes/Mitigation Info/Possible Solution		Field Measurements/Component Compliance

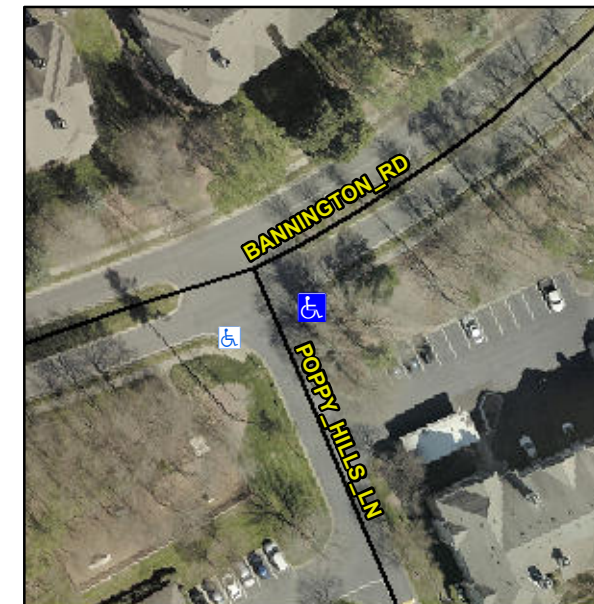
**Not Found, R304.2.2, R304.5.3**

Compliance	Description	Data	Compliance	Description	Data
N/A	Ramp Length (in)	96.0	No	Ramp Slope (%)	10.1
Yes	Ramp Width (in)	48.0	No	Ramp XSlope (%)	4.4
N/A	Flare Type LT	N/A	N/A	Flare Type RT	N/A
N/A	Flare Slope LT (%)	N/A	N/A	Flare Slope RT (%)	N/A
N/A	Flare Traversable LT?	N/A	N/A	Flare Traversable RT?	N/A
N/A	Landing Length (in)	N/A	N/A	DWS Provided?	N/A
N/A	Landing Width (in)	N/A	N/A	DWS Contrast?	N/A
N/A	Landing Slope (%)	N/A	N/A	DWS Length (in)	N/A
N/A	Landing X Slope (%)	N/A	N/A	DWS Full Width?	N/A
N/A	Landing Curb? (Y/N)	N/A	N/A	DWS Offset (in)	N/A
N/A	Shared Landing?	N/A			
N/A	Gutter Ponding?	N/A	N/A	Gutter Slope (%)	N/A
N/A	Gutter Lip Ht (in)	N/A	N/A	Gutter X Slope (%)	N/A
N/A	Painted X Walk1?	No	N/A	Painted X Walk2?	No
	X Walk 1 Direction	To N		X Walk 2 Direction	To W
N/A	X Walk 1 Width (in)	N/A	N/A	X Walk 2 Width (in)	N/A
	X Walk 1 Slope (%)	4.5		X Walk 2 Slope (%)	0.2
	X Walk 1 X Slope (%)	1.2		X Walk 2 X Slope (%)	4.9

N/A	Ramp inside XWalk1?	N/A	N/A	Ramp inside XWalk2?	N/A
	Road Slope (%)	1.2	N/A	Clear Space?	N/A
	Road X Slope (%)	2.7	N/A	Clear Space to XWalk (in)	N/A
N/A	Any Obstructions?	N/A	N/A	Storm Grate/Utility Hazard?	N/A
	Obstruction Type			Storm Grate/Utility Type	
		N/A			N/A
		Yes		Surface Condition? (G/P)	Good

**Remove & Replace Curb Ramp With Two New Directional Ramps or Equivalent.**
