## Access Compliance Report Public Rights-of-Way (Curb Ramps)

Intersection ID: 50704 Main Street: REUNION\_ST Cross Street: HARMONIOUS\_ST Location: W

ADA ID: 8FE950D85619 Ramp Type: BlendTrans1 Initial Pass/Fail: Fail Overall Compliance: No Severity Score: 33.75

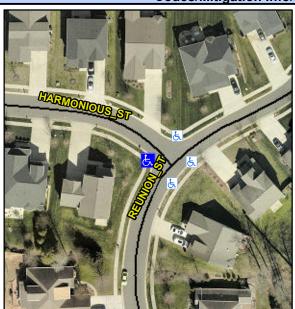
Not Found, R304.5.1, R304.5.3

Compliance Description Data Compliance Description Data					
N/A Ramp Length (in)		50.0	Yes BlendTrans Slope (%)		4.8
No.	Ramp Width (in)	47.3	No	BlendTrans XSlope (%)	7.5
N/A	Flare Type LT	47.3 N/A	N/A	Flare Type RT	N/A
N/A	Flare Slope LT (%)	N/A	N/A	Flare Slope RT (%)	N/A
N/A	Flare Traversable LT?		N/A	Flare Traversable RT?	
N/A N/A		N/A N/A	N/A N/A	DWS Provided?	N/A N/A
	Landing Length (in)				
N/A	Landing Width (in)	N/A	N/A	DWS Contrast?	N/A
N/A	Landing Slope (%)	N/A	N/A	DWS Length (in)	N/A
N/A	Landing X Slope (%)	N/A	N/A	DWS Full Width?	N/A
N/A	Landing Curb? (Y/N)	N/A	N/A	DWS Offset (in)	N/A
N/A	Shared Landing?	N/A			
N/A	Gutter Ponding?	N/A	N/A	Gutter Slope (%)	N/A
N/A	Gutter Lip Ht (in)	N/A	N/A	Gutter X Slope (%)	N/A
N/A	Painted X Walk1?	No	N/A	Painted X Walk2?	No
	X Walk 1 Direction	To SE		X Walk 2 Direction	To NE
	X Walk 1 Width (in)	N/A		X Walk 2 Width (in)	N/A
	X Walk 1 Slope (%)	3.4		X Walk 2 Slope (%)	0.5

X Walk 1 X Slope (%)	5.2		X Walk 2 X Slope (%)	5.5
N/A	Ramp inside XWalk1?	N/A	N/A	Ramp inside XWalk2?	N/A
	Road Slope (%)	6.6		Clear Space?	N/A
	Road X Slope (%)	0.6	N/A	Clear Space to XWalk (in)	N/A
N/A	Any Obstructions?	N/A	N/A	Storm Grate/Utility Hazard?	N/A
	Obstruction Type		l	Storm Grate/Utility Type	
		N/A	l		N/A
			Yes	Surface Condition? (G/P)	Good
			No	Curb Slope (%)	5.8
		,	•

Remove & Replace Curb Ramp With Two New Directional Ramps or Equivalent.
