Access Compliance Report Public Rights-of-Way (Curb Ramps)

| Intersection ID: 10024247 Main Street: CPCC_HARRIS_CAMPUS_DR Cross Street: N/A Location: | | | | | | | | | | NE |
| ADA ID: 8FEF8F8C5768 Ramp Type: PerpDiag | | | | Initial | Pass/Fa | ail: Fail Overall | | 36.25 | | |

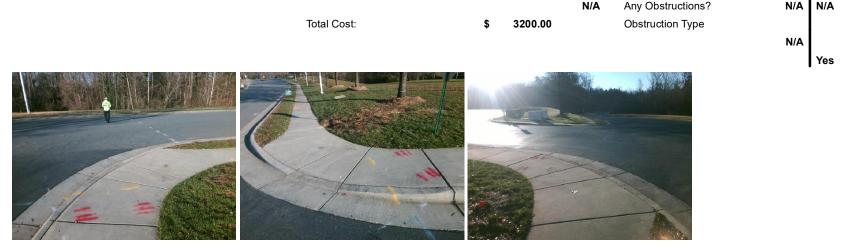
| Intersection ID: 10024247 Main Street: CPCC_HARRIS_CAMPUS_DR Cross Street: N/A Location: | | | | | | | | | | NE |
|--|---|--|---|---|---|---|---|---|---|---|
| | | Two New Directional Ramps Equivalent. | imps or | r | No | Ramp Width (in) | 26.0 | No | Ramp XSlope (%) | 2.4 |
| Not Found, R304.5.1, R304.5.3 | | | | N/A | Gutter Lip Ht (in) | N/A | N/A | Gutter X Slope (%) | N/A | |

| Intersection ID: 10024247 Main Street: CPCC_HARRIS_CAMPUS_DR Cross Street: N/A Location: | | | | | | | | | | NE |
|--|---|--|---|---|---|---|---|---|---|---|
| 12 30 | | Remove & Replace Curb | Ramp | With | N/A | Ramp Length (in) | 74.0 | Yes | Ramp Slope (%) | 5.7 |
| | | Total Cost: | \$ | 3200.00 | | Obstruction Type | | | Storm Grate/Utility Type | |
