Access Compliance Report Public Rights-of-Way (Curb Ramps)

Intersection ID: 15195 Main Street: ALBEMARLE_RD Cross Street: FARM_POND_LN Location: N

ADA ID: 8FF73DFFAB09 Ramp Type: MedianPerp Initial Pass/Fail: Fail Overall Compliance: No Severity Score: 10

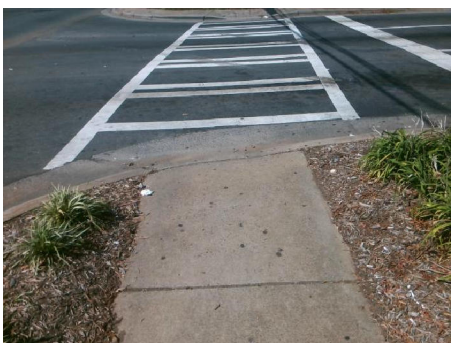
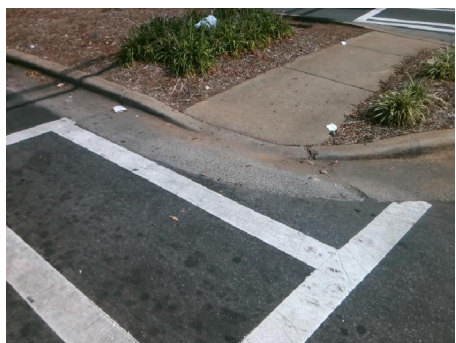
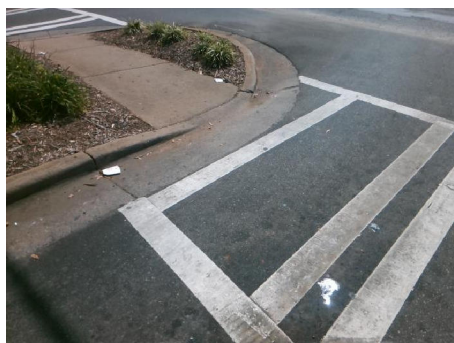
PROW/ADA:
Not Found, R304.5.1, R304.5.3

Compliance	Description	Data	Compliance	Description	Data
N/A	Ramp Length (in)	58.0	Yes	Ramp Slope (%)	6.8
No	Ramp Width (in)	41.0	No	Ramp XSlope (%)	2.7
N/A	Flare Type LT	N/A	N/A	Flare Type RT	N/A
N/A	Flare Slope LT (%)	N/A	N/A	Flare Slope RT (%)	N/A
N/A	Flare Traversable LT?	N/A	N/A	Flare Traversable RT?	N/A
N/A	Landing Length (in)	N/A	N/A	DWS Provided?	N/A
N/A	Landing Width (in)	N/A	N/A	DWS Contrast?	N/A
N/A	Landing Slope (%)	N/A	N/A	DWS Length (in)	N/A
N/A	Landing X Slope (%)	N/A	N/A	DWS Full Width?	N/A
N/A	Landing Curb? (Y/N)	N/A	N/A	DWS Offset (in)	N/A
N/A	Shared Landing?	N/A			
N/A	Gutter Ponding?	N/A	N/A	Gutter Slope (%)	N/A
N/A	Gutter Lip Ht (in)	N/A	N/A	Gutter X Slope (%)	N/A
N/A	Painted X Walk1?	Yes	N/A	Painted X Walk2?	N/A
	X Walk 1 Direction	To W		X Walk 2 Direction	N/A
N/A	X Walk 1 Width (in)	113.0	N/A	X Walk 2 Width (in)	N/A
	X Walk 1 Slope (%)	1.8		X Walk 2 Slope (%)	N/A
	X Walk 1 X Slope (%)	1.7		X Walk 2 X Slope (%)	N/A

N/A	Ramp inside XWalk1?	Yes	N/A	Ramp inside XWalk2?	N/A
	Road Slope (%)	N/A	N/A	Clear Space?	N/A
	Road X Slope (%)	N/A	N/A	Clear Space to XWalk (in)	N/A
N/A	Any Obstructions?	N/A	N/A	Storm Grate/Utility Hazard?	N/A
	Obstruction Type			Storm Grate/Utility Type	
		N/A			N/A
			Yes	Surface Condition? (G/P)	Good

Possible Solutions:
Remove & Replace Entire Ramp.
