Access Compliance Report Public Rights-of-Way (Curb Ramps)

Intersection ID: 14213	Main Street: CENTRAL_AV	Cross Street: ROSEHAVEN_DR	Location: SW
ADA ID: 8FFB8420DF55	Ramp Type: Para	Initial Pass/Fail: Fail	Overall Compliance: No Severity Score: 12.5

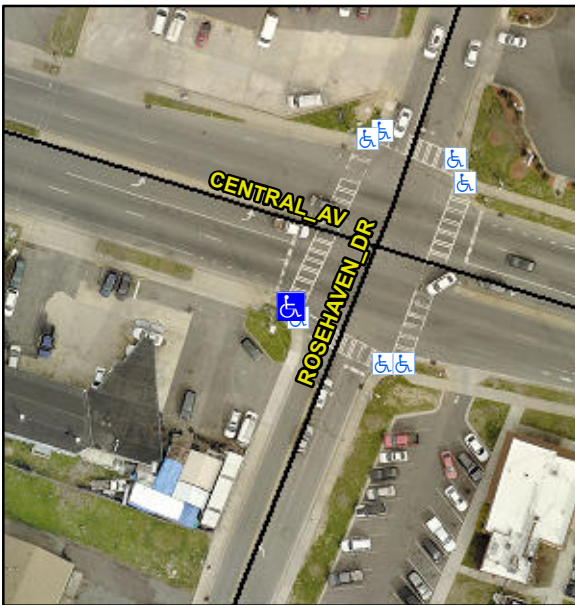
R304.3.2

Compliance	Description	Data	Compliance	Description	Data
N/A	Ramp Length LT (in)	26.5	N/A	Ramp Length RT (in)	52.5
Yes	Ramp Width LT (in)	71.0	Yes	Ramp Width RT (in)	71.0
Yes	Ramp Slope LT (%)	5.0	No	Ramp Slope RT (%)	10.6
Yes	Ramp XSlope LT (%)	1.0	Yes	Ramp XSlope RT (%)	1.7
N/A	Landing Length (in)	N/A	N/A	DWS Provided?	N/A
N/A	Landing Width (in)	N/A	N/A	DWS Contrast?	N/A
N/A	Landing Slope (%)	N/A	N/A	DWS Length (in)	N/A
N/A	Landing X Slope (%)	N/A	N/A	DWS Full Width?	N/A
N/A	Landing Curb? (Y/N)	N/A	N/A	DWS Offset (in)	N/A
N/A	Shared Landing?	N/A			
N/A	Gutter Ponding?	N/A	N/A	Gutter Slope (%)	N/A
N/A	Gutter Lip Ht (in)	N/A	N/A	Gutter X Slope (%)	N/A
N/A	Painted X Walk1?	Yes	N/A	Painted X Walk2?	N/A
	X Walk 1 Direction	To N		X Walk 2 Direction	N/A
N/A	X Walk 1 Width (in)	108.0	N/A	X Walk 2 Width (in)	N/A
	X Walk 1 Slope (%)	0.5		X Walk 2 Slope (%)	N/A
	X Walk 1 X Slope (%)	3.1		X Walk 2 X Slope (%)	N/A
N/A	Ramp inside XWalk1?	Yes	N/A	Ramp inside XWalk2?	N/A

Road Slope (%)	N/A	N/A	Clear Space?	N/A
	Road X Slope (%)	N/A	N/A	Clear Space to XWalk (in)	N/A
N/A	Any Obstructions?	N/A	N/A	Storm Grate/Utility Hazard?	N/A
	Obstruction Type			Storm Grate/Utility Type	
	Total Cost:	\$ 1600.00	N/A		N/A
			Yes	Surface Condition? (G/P)	Good
			N/A	Curb Slope (%)	25.7

Remove & Replace Entire Ramp.
