# Access Compliance Report

## Public Rights-of-Way

### (Curb Ramps)

Intersection ID: 29416	Main Street: PADDORBORN_CT	Cross Street: SALINGER_WY	Location: E
ADA ID: 9000947596B6	Ramp Type: Perp	Initial Pass/Fail: Fail	Overall Compliance: No
Codes/Mitigation Info/Possible Solution		Field Measurements/Component Compliance	
Severity Score: 33.75

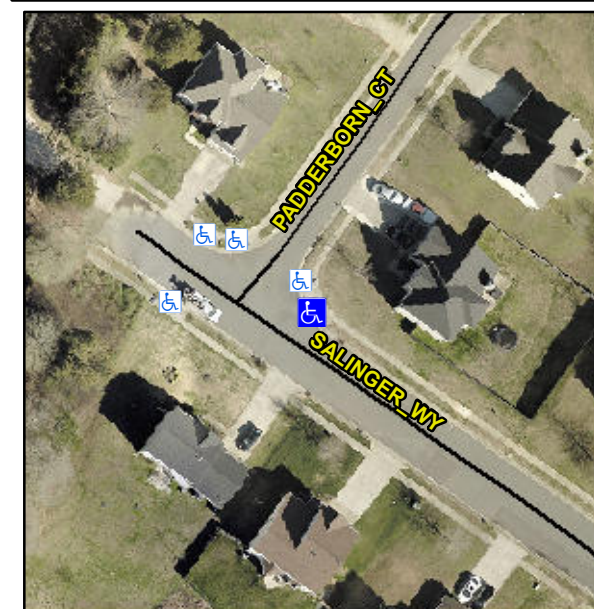
**Not Found, R304.5.1, R304.2.2**

Compliance	Description	Data	Compliance	Description	Data
N/A	Ramp Length (in)	62.5	No	Ramp Slope (%)	13.8
No	Ramp Width (in)	45.5	Yes	Ramp XSlope (%)	1.4
N/A	Flare Type LT	N/A	N/A	Flare Type RT	N/A
N/A	Flare Slope LT (%)	N/A	N/A	Flare Slope RT (%)	N/A
N/A	Flare Traversable LT?	N/A	N/A	Flare Traversable RT?	N/A
N/A	Landing Length (in)	N/A	N/A	DWS Provided?	N/A
N/A	Landing Width (in)	N/A	N/A	DWS Contrast?	N/A
N/A	Landing Slope (%)	N/A	N/A	DWS Length (in)	N/A
N/A	Landing X Slope (%)	N/A	N/A	DWS Full Width?	N/A
N/A	Landing Curb? (Y/N)	N/A	N/A	DWS Offset (in)	N/A
N/A	Shared Landing?	N/A			
N/A	Gutter Ponding?	N/A	N/A	Gutter Slope (%)	N/A
N/A	Gutter Lip Ht (in)	N/A	N/A	Gutter X Slope (%)	N/A
N/A	Painted X Walk1?	No	N/A	Painted X Walk2?	N/A
	X Walk 1 Direction	To SW		X Walk 2 Direction	N/A
N/A	X Walk 1 Width (in)	N/A	N/A	X Walk 2 Width (in)	N/A
	X Walk 1 Slope (%)	4.1		X Walk 2 Slope (%)	N/A
	X Walk 1 X Slope (%)	3.4		X Walk 2 X Slope (%)	N/A

**Remove & Replace Entire Ramp.**

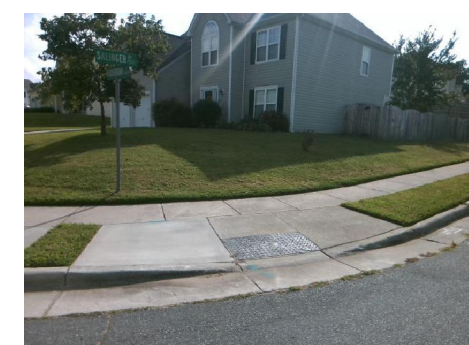
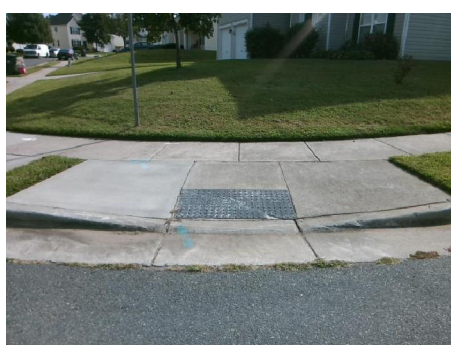
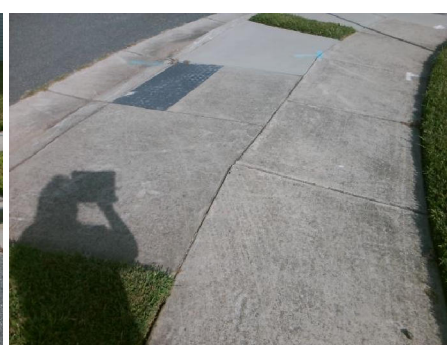
N/A	Ramp inside XWalk1?	N/A	N/A	Ramp inside XWalk2?	N/A
	Road Slope (%)	N/A	N/A	Clear Space?	N/A
	Road X Slope (%)	N/A	N/A	Clear Space to XWalk (in)	N/A
N/A	Any Obstructions?	N/A	N/A	Storm Grate/Utility Hazard?	N/A
	Obstruction Type			Storm Grate/Utility Type	
		N/A			N/A
			Yes	Surface Condition? (G/P)	Good
