# Access Compliance Report

## Public Rights-of-Way

### (Curb Ramps)

Intersection ID: 8513	Main Street: MCARTHUR_AV	Cross Street: MONTREAT_ST	Location: SW
ADA ID: 900097991399	Ramp Type: Perp	Initial Pass/Fail: Fail	Overall Compliance: No
Severity Score: 13.75			
Codes/Mitigation Info/Possible Solution		Field Measurements/Component Compliance

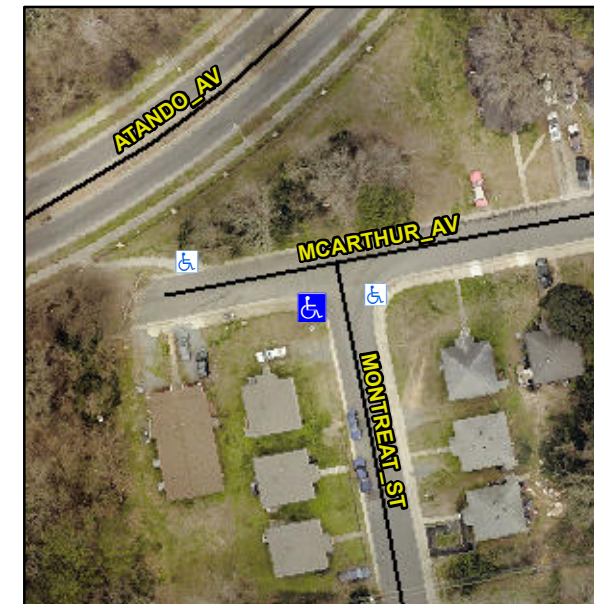
**Not Found, R304.2.2, R304.5.3**

Compliance	Description	Data	Compliance	Description	Data
N/A	Ramp Length (in)	62.0	No	Ramp Slope (%)	9.1
Yes	Ramp Width (in)	63.0	No	Ramp XSlope (%)	4.6
N/A	Flare Type LT	N/A	N/A	Flare Type RT	N/A
N/A	Flare Slope LT (%)	N/A	N/A	Flare Slope RT (%)	N/A
N/A	Flare Traversable LT?	N/A	N/A	Flare Traversable RT?	N/A
N/A	Landing Length (in)	N/A	N/A	DWS Provided?	N/A
N/A	Landing Width (in)	N/A	N/A	DWS Contrast?	N/A
N/A	Landing Slope (%)	N/A	N/A	DWS Length (in)	N/A
N/A	Landing X Slope (%)	N/A	N/A	DWS Full Width?	N/A
N/A	Landing Curb? (Y/N)	N/A	N/A	DWS Offset (in)	N/A
N/A	Shared Landing?	N/A			
N/A	Gutter Ponding?	N/A	N/A	Gutter Slope (%)	N/A
N/A	Gutter Lip Ht (in)	N/A	N/A	Gutter X Slope (%)	N/A
N/A	Painted X Walk1?	No	N/A	Painted X Walk2?	N/A
	X Walk 1 Direction	To E		X Walk 2 Direction	N/A
N/A	X Walk 1 Width (in)	N/A	N/A	X Walk 2 Width (in)	N/A
	X Walk 1 Slope (%)	3.9		X Walk 2 Slope (%)	N/A
	X Walk 1 X Slope (%)	4.8		X Walk 2 X Slope (%)	N/A

N/A	Ramp inside XWalk1?	N/A	N/A	Ramp inside XWalk2?	N/A
	Road Slope (%)	N/A	N/A	Clear Space?	N/A
	Road X Slope (%)	N/A	N/A	Clear Space to XWalk (in)	N/A
N/A	Any Obstructions?	N/A	N/A	Storm Grate/Utility Hazard?	N/A
	Obstruction Type			Storm Grate/Utility Type	
		N/A			N/A
			Yes	Surface Condition? (G/P)	Good

**Remove & Replace Entire Ramp.**
