# Access Compliance Report

## Public Rights-of-Way

### (Curb Ramps)

Intersection ID: 24356	Main Street: BEVERLY_CREST_BV	Cross Street: CAMAROSS_DR	Location: NE
ADA ID: 900311BDED76	Ramp Type: Perp	Initial Pass/Fail: Fail	Overall Compliance: No
Severity Score: 12.5			
Codes/Mitigation Info/Possible Solution		Field Measurements/Component Compliance

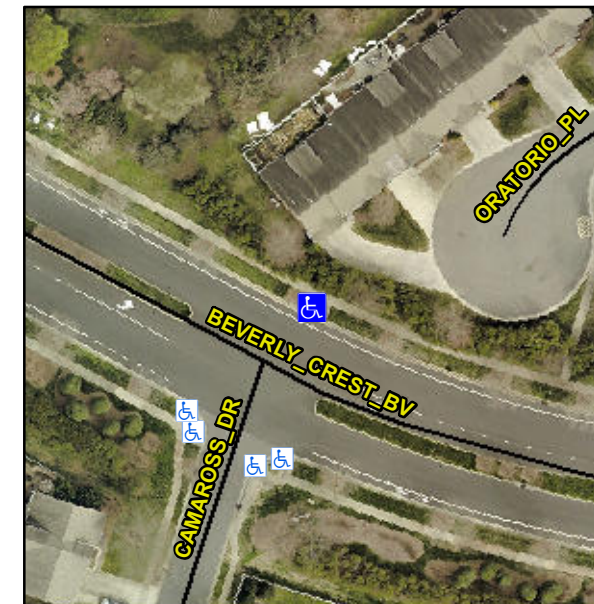
**Not Found, R304.2.2**

Compliance	Description	Data	Compliance	Description	Data
N/A	Ramp Length (in)	95.5	No	Ramp Slope (%)	8.5
Yes	Ramp Width (in)	120.0	Yes	Ramp XSlope (%)	0.5
N/A	Flare Type LT	N/A	N/A	Flare Type RT	N/A
N/A	Flare Slope LT (%)	N/A	N/A	Flare Slope RT (%)	N/A
N/A	Flare Traversable LT?	N/A	N/A	Flare Traversable RT?	N/A
N/A	Landing Length (in)	N/A	N/A	DWS Provided?	N/A
N/A	Landing Width (in)	N/A	N/A	DWS Contrast?	N/A
N/A	Landing Slope (%)	N/A	N/A	DWS Length (in)	N/A
N/A	Landing X Slope (%)	N/A	N/A	DWS Full Width?	N/A
N/A	Landing Curb? (Y/N)	N/A	N/A	DWS Offset (in)	N/A
N/A	Shared Landing?	N/A			
N/A	Gutter Ponding?	N/A	N/A	Gutter Slope (%)	N/A
N/A	Gutter Lip Ht (in)	N/A	N/A	Gutter X Slope (%)	N/A
N/A	Painted X Walk1?	No	N/A	Painted X Walk2?	N/A
	X Walk 1 Direction	To S		X Walk 2 Direction	N/A
N/A	X Walk 1 Width (in)	N/A	N/A	X Walk 2 Width (in)	N/A
	X Walk 1 Slope (%)	2.6		X Walk 2 Slope (%)	N/A
	X Walk 1 X Slope (%)	0.6		X Walk 2 X Slope (%)	N/A

N/A	Ramp inside XWalk1?	N/A	N/A	Ramp inside XWalk2?	N/A
	Road Slope (%)	N/A	N/A	Clear Space?	N/A
	Road X Slope (%)	N/A	N/A	Clear Space to XWalk (in)	N/A
N/A	Any Obstructions?	N/A	N/A	Storm Grate/Utility Hazard?	N/A
	Obstruction Type			Storm Grate/Utility Type	
		N/A			N/A
			Yes	Surface Condition? (G/P)	Good

**Remove & Replace Entire Ramp.**

Total Cost: \$ 1850.00
