# Access Compliance Report

## Public Rights-of-Way

### (Curb Ramps)

Intersection ID: 29429	Main Street: BRADSTREET_COMMONS_WY	Cross Street: DELUCA_DR	Location:	S
ADA ID: 90116022356F	Ramp Type: Combination2	Initial Pass/Fail: Fail	Overall Compliance: No	Severity Score: 10
Codes/Mitigation Info/Possible Solution		Field Measurements/Component Compliance

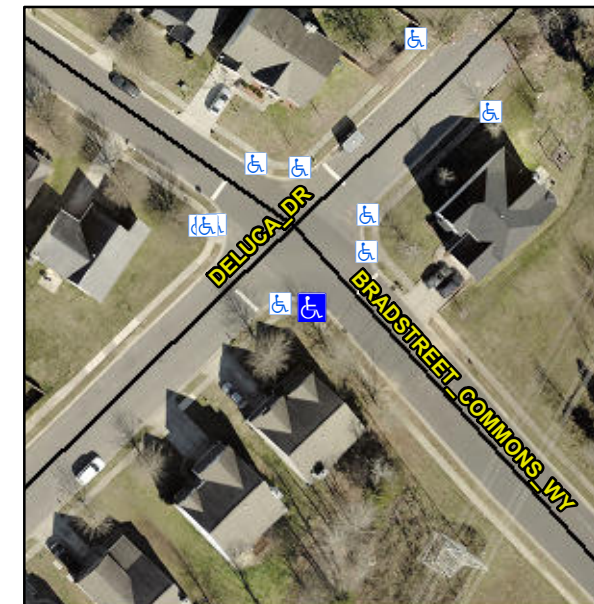
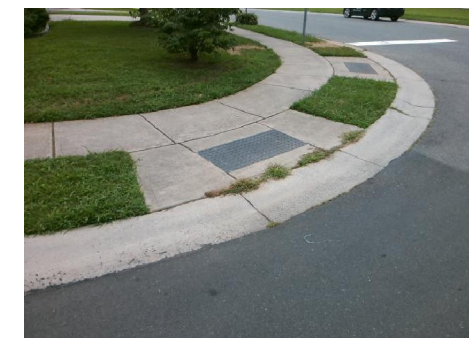
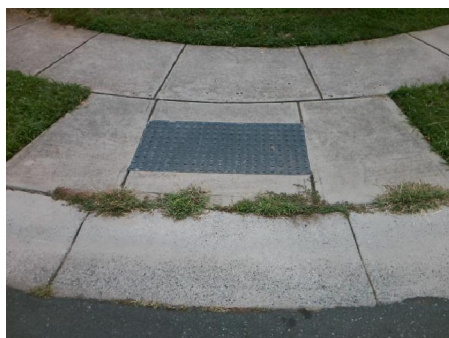
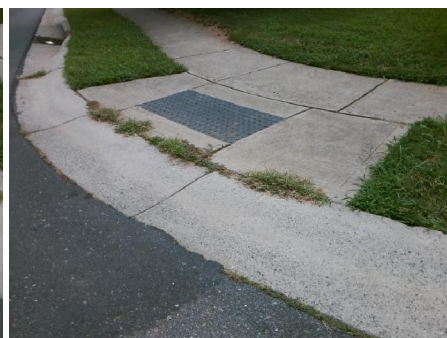
**LT RP < 5%**

**Not Found, R304.5.1**

Compliance	Description	Data	Compliance	Description	Data
N/A	Ramp Length LT (in)	41.0	N/A	Ramp Length RT (in)	52.0
N/A	Ramp Width LT (in)	48.0	Yes	Ramp Width RT (in)	48.0
N/A	Ramp Slope LT (%)	3.3	Yes	Ramp Slope RT (%)	7.9
N/A	Ramp XSlope LT (%)	3.5	Yes	Ramp XSlope RT (%)	1.1
N/A	Ramp Length (in)	47.0	Yes	Ramp Slope (%)	2.3
No	Ramp Width (in)	47.0	Yes	Ramp XSlope (%)	1.6
N/A	Flare Type LT	N/A	N/A	Flare Type RT	N/A
N/A	Flare Slope LT (%)	N/A	N/A	Flare Slope RT (%)	N/A
N/A	Flare Traversable LT?	N/A	N/A	Flare Traversable RT?	N/A
N/A	Landing Length (in)	N/A	N/A	DWS Provided?	N/A
N/A	Landing Width (in)	N/A	N/A	DWS Contrast?	N/A
N/A	Landing Slope (%)	N/A	N/A	DWS Length (in)	N/A
N/A	Landing X Slope (%)	N/A	N/A	DWS Full Width?	N/A
N/A	Landing Curb? (Y/N)	N/A	N/A	DWS Offset (in)	N/A
N/A	Shared Landing?	N/A			
N/A	Gutter Ponding?	N/A	N/A	Gutter Slope (%)	N/A
N/A	Gutter Lip Ht (in)	N/A	N/A	Gutter X Slope (%)	N/A
N/A	Painted X Walk1?	No	N/A	Painted X Walk2?	N/A

X Walk 1 Direction	To NE		X Walk 2 Direction	N/A
	X Walk 1 Width (in)	N/A		X Walk 2 Width (in)	N/A
	X Walk 1 Slope (%)	2.1		X Walk 2 Slope (%)	N/A
	X Walk 1 X Slope (%)	0.6		X Walk 2 X Slope (%)	N/A
N/A	Ramp inside XWalk1?	N/A	N/A	Ramp inside XWalk2?	N/A
	Road Slope (%)	N/A		Clear Space?	N/A
	Road X Slope (%)	N/A	N/A	Clear Space to XWalk (in)	N/A
			N/A	Any Obstruction?	N/A
				Obstruction Type	N/A
			N/A	Storm Grate/Utility Hazard?	N/A
				Storm Grate/Utility Type	N/A
			Yes	Surface Condition? (G/P)	Good
				Curb Slope (%)	21.7

**Remove & Replace Entire Ramp.**

Total Cost: \$ 1600.00
