## **Access Compliance Report Public Rights-of-Way** (Curb Ramps)

Intersection ID: 51358 Main Street: PIKE RD **Cross Street: BRENTMOOR DR** Location: S **Overall Compliance: No Severity Score:**

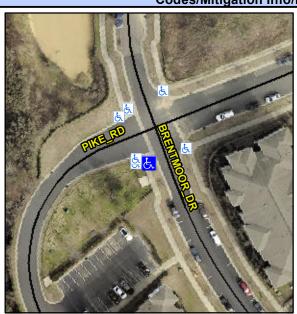
Initial Pass/Fail: Fail

Compliance Description Data Compliance Description Data Yes Ramp Slope (%) N/A Ramp Length (in) 48.0 6.8 Yes Ramp XSlope (%) Ramp Width (in) 47.5 0.2 N/A Flare Type LT N/A Flare Type RT N/A N/A N/A Flare Slope RT (%) N/A Flare Slope LT (%) Flare Traversable LT? N/A N/A Flare Traversable RT? N/A N/A N/A **DWS Provided?** N/A Landing Length (in) Landing Width (in) N/A N/A **DWS Contrast?** N/A N/A N/A Landing Slope (%) DWS Length (in) N/A Landing X Slope (%) N/A N/A DWS Full Width? N/A Landing Curb? (Y/N) N/A N/A DWS Offset (in) N/A N/A Shared Landing? **Gutter Ponding?** N/A N/A Gutter Slope (%) N/A Gutter Lip Ht (in) N/A N/A Gutter X Slope (%) N/A Painted X Walk1? No N/A Painted X Walk2? No X Walk 1 Direction To E X Walk 2 Direction To N N/A X Walk 1 Width (in) X Walk 2 Width (in) N/A X Walk 1 Slope (%) 1.5 X Walk 2 Slope (%) 1.1 X Walk 2 X Slope (%) X Walk 1 X Slope (%) 2.1 2.3 N/A N/A Ramp inside XWalk2? N/A Ramp inside XWalk1? Road Slope (%) 0.7 N/A Clear Space? N/A N/A Road X Slope (%) Clear Space to XWalk (in) N/A 1.6 N/A N/A N/A Any Obstructions? Storm Grate/Utility Hazard? N/A **Obstruction Type** Storm Grate/Utility Type N/A N/A

**BRENTMOOR DR** Street 1 Name Stop Condition-Street 2 None **PIKE RD** Street 2 Name Stop Condition-Street 1 StopSign Possible Solutions: Remove & Replace Curb Ramp With Two New Directional Ramps or Equivalent. Surveyor Notes: N/A PROW/ADA: Not Found, R304.5.1
