Access Compliance Report

Public Rights-of-Way (Curb Ramps)

Intersection ID: 15776	Main Street: HERTFORD_RD	Cross Street: HOPEDALE_AV	Location: SW
ADA ID: 90167059345E	Ramp Type: Directional1	Initial Pass/Fail: Fail	Overall Compliance: No
		Severity Score: 1.25

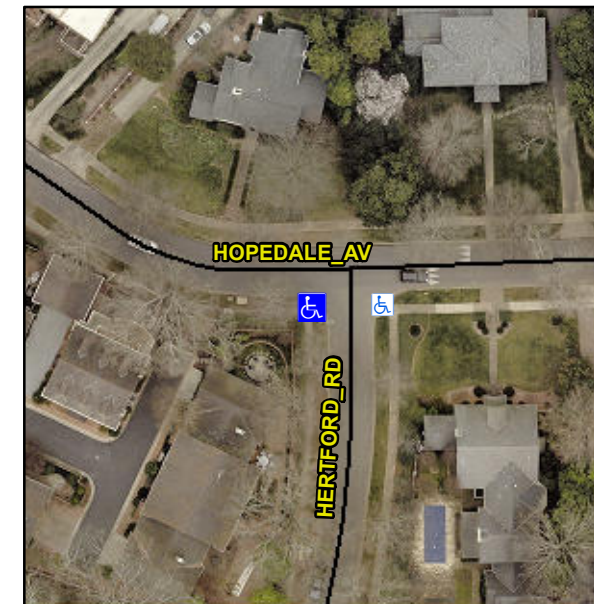
Compliance	Description	Data	Compliance	Description	Data
N/A	Ramp Length (in)	39.0	N/A	Grade Break?	N/A
Yes	Ramp Width (in)	48.0	N/A	Grade Break Slope (%)	0.0
Yes	Ramp Slope (%)	1.1	N/A	Grade Break XSlope (%)	0.0
No	Ramp XSlope (%)	3.8			
N/A	Flare Type LT	N/A	N/A	Flare Type RT	N/A
N/A	Flare Slope LT (%)	N/A	N/A	Flare Slope RT (%)	0.0
N/A	Flare Traversable LT?	N/A	N/A	Flare Traversable RT?	N/A
N/A	Landing Length (in)	0.0	N/A	DWS Provided?	N/A
N/A	Landing Width (in)	0.0	N/A	DWS Contrast?	N/A
N/A	Landing Slope (%)	0.0	N/A	DWS Length (in)	N/A
N/A	Landing X Slope (%)	0.0	N/A	DWS Full Width?	N/A
N/A	Landing Curb? (Y/N)	N/A	N/A	DWS Offset LT (in)	N/A
N/A	Shared Landing?	N/A	N/A	DWS Offset RT (in)	N/A
N/A	Gutter Ponding?	0.0	N/A	Gutter Slope (%)	N/A
N/A	Gutter Lip Ht (in)	0.0	N/A	Gutter X Slope (%)	N/A
N/A	Painted X Walk1?	No		Road Slope (%)	5.0
	X Walk 1 Direction	To NE		Road X Slope (%)	0.3
	X Walk 1 Width (in)	N/A		Clear Space?	N/A

X Walk 1 Slope (%)	5.0	N/A	Clear Space to XWalk (in)	N/A
	X Walk 1 X Slope (%)	0.3	N/A	Storm Grate/Utility Hazard?	N/A
N/A	Ramp inside XWalk1?	N/A		Storm Grate/Utility Type	
N/A	Any Obstructions?	N/A			N/A
	Obstruction Type		Yes	Surface Condition? (G/P)	Good
			N/A	Curb Slope (%)	13.2

Remove & Replace Entire Ramp.

R304.5.3

\$ 1600.00
