## **Access Compliance Report Public Rights-of-Way** (Curb Ramps)

Cross Street: PARK RD Intersection ID: 14851 Main Street: E WORTHINGTON AV Location: S

Initial Pass/Fail: Fail **Overall Compliance: No Severity Score:** 1.25 **ADA ID: 901CD7C33AD7** Ramp Type: Perp

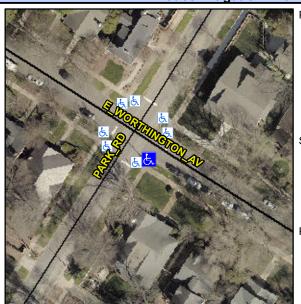
**E WORTHINGTON AV** Street 1 Name Stop Condition-Street 2 StopSign N/A Street 2 Name Stop Condition-Street 1 N/A Possible Solutions: Remove & Replace Entire Ramp. Surveyor Notes: N/A PROW/ADA: R304.5.3
