Access Compliance Report

Public Rights-of-Way

(Curb Ramps)

Intersection ID: 3127	Main Street: GEMSTONE_CT	Cross Street: MINERAL_RIDGE_WY	Location: E
ADA ID: 902C0460C56A	Ramp Type: Perp	Initial Pass/Fail: Fail	Overall Compliance: No
Severity Score: 36.25			
Codes/Mitigation Info/Possible Solution		Field Measurements/Component Compliance

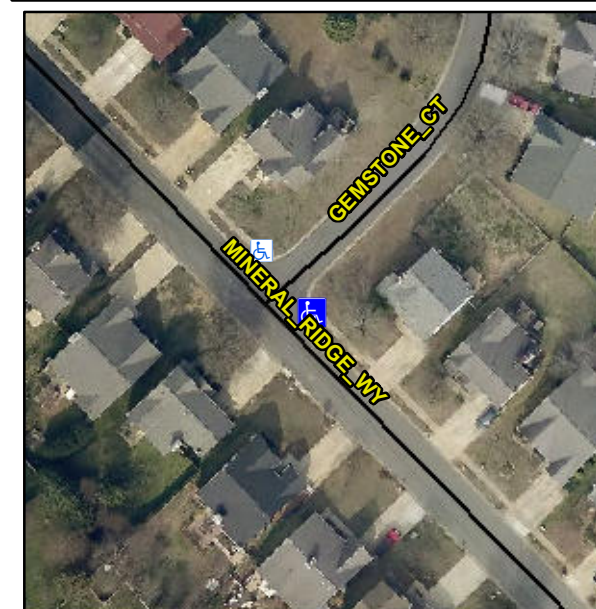
Not Found, R304.5.1, R304.5.3

Compliance	Description	Data	Compliance	Description	Data
N/A	Ramp Length (in)	92.0	Yes	Ramp Slope (%)	5.2
No	Ramp Width (in)	30.5	No	Ramp XSlope (%)	4.1
N/A	Flare Type LT	N/A	N/A	Flare Type RT	N/A
N/A	Flare Slope LT (%)	N/A	N/A	Flare Slope RT (%)	N/A
N/A	Flare Traversable LT?	N/A	N/A	Flare Traversable RT?	N/A
N/A	Landing Length (in)	N/A	N/A	DWS Provided?	N/A
N/A	Landing Width (in)	N/A	N/A	DWS Contrast?	N/A
N/A	Landing Slope (%)	N/A	N/A	DWS Length (in)	N/A
N/A	Landing X Slope (%)	N/A	N/A	DWS Full Width?	N/A
N/A	Landing Curb? (Y/N)	N/A	N/A	DWS Offset (in)	N/A
N/A	Shared Landing?	N/A			
N/A	Gutter Ponding?	N/A	N/A	Gutter Slope (%)	N/A
N/A	Gutter Lip Ht (in)	N/A	N/A	Gutter X Slope (%)	N/A
N/A	Painted X Walk1?	No	N/A	Painted X Walk2?	N/A
	X Walk 1 Direction	To NW		X Walk 2 Direction	N/A
N/A	X Walk 1 Width (in)	N/A	N/A	X Walk 2 Width (in)	N/A
	X Walk 1 Slope (%)	2.1		X Walk 2 Slope (%)	N/A
	X Walk 1 X Slope (%)	2.5		X Walk 2 X Slope (%)	N/A

Possible Solutions:

Remove & Replace Entire Ramp.
