## **Access Compliance Report Public Rights-of-Way** (Curb Ramps)

Intersection ID: 13598 Main Street: W KINGSTON AV Cross Street: WICKFORD PL Location: NW **Overall Compliance: No Severity Score:** ADA ID: 9035F92F3A41 Ramp Type: Directional1 Initial Pass/Fail: Fail 1.25

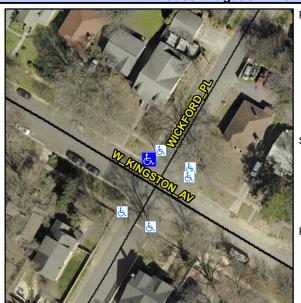
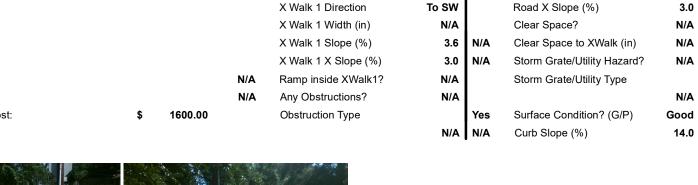
W KINGSTON AV Street 1 Name Stop Condition-Street 1 StopSign N/A Street 2 Name Stop Condition-Street 2 N/A Possible Solutions: Remove & Replace Entire Ramp. Surveyor Notes: N/A PROW/ADA: R304.5.3
