## **Access Compliance Report Public Rights-of-Way** (Curb Ramps)

Intersection ID: 31553 Main Street: CALDWELL RD **Cross Street: CALDWELL RIDGE PY** Location: ADA ID: 9039886CB09C Ramp Type: PerpDiag Initial Pass/Fail: Fail **Overall Compliance: No** Severity Score: 21.25

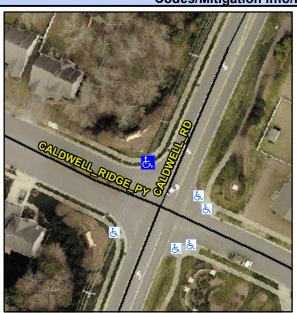
Fleid Measurements/Component Compliance						
	Comp	liance Description	Data	Comp	oliance Description	Data
	N/A	Ramp Length (in)	50.5	No	Ramp Slope (%)	8.4
	No	Ramp Width (in)	46.0	Yes	Ramp XSlope (%)	0.9
	N/A	Flare Type LT	N/A	N/A	Flare Type RT	N/A
	N/A	Flare Slope LT (%)	N/A	N/A	Flare Slope RT (%)	N/A
	N/A	Flare Traversable LT?	N/A	N/A	Flare Traversable RT?	N/A
	N/A	Landing Length (in)	N/A	N/A	DWS Provided?	N/A
	N/A	Landing Width (in)	N/A	N/A	DWS Contrast?	N/A
	N/A	Landing Slope (%)	N/A	N/A	DWS Length (in)	N/A
	N/A	Landing X Slope (%)	N/A	N/A	DWS Full Width?	N/A
	N/A	Landing Curb? (Y/N)	N/A	N/A	DWS Offset (in)	N/A
	N/A	Shared Landing?	N/A			
	N/A	Gutter Ponding?	N/A	N/A	Gutter Slope (%)	N/A
	N/A	Gutter Lip Ht (in)	N/A	N/A	Gutter X Slope (%)	N/A
	N/A	Painted X Walk1?	No	N/A	Painted X Walk2?	No
		X Walk 1 Direction	To SW		X Walk 2 Direction	To SE
	N/A	X Walk 1 Width (in)	N/A	N/A	X Walk 2 Width (in)	N/A
		X Walk 1 Slope (%)	2.7		X Walk 2 Slope (%)	5.5

X Walk 1 X Slope (%)	3.4		X Walk 2 X Slope (%)	0.8
	N/A	Ramp inside XWalk1?	N/A	N/A	Ramp inside XWalk2?	N/A
		Road Slope (%)	0.2	N/A	Clear Space?	N/A
		Road X Slope (%)	5.6	N/A	Clear Space to XWalk (in)	N/A
	N/A	Any Obstructions?	N/A	N/A	Storm Grate/Utility Hazard?	N/A
		Obstruction Type			Storm Grate/Utility Type	
			N/A			N/A
				Yes	Surface Condition? (G/P)	Good
			· ·	-

Possible Solutions: **Remove & Replace Curb Ramp With** Two New Directional Ramps or Equivalent. Surveyor Notes: N/A PROW/ADA: Not Found, R304.5.1, R304.2.2
