# Access Compliance Report

## Public Rights-of-Way

### (Curb Ramps)

| Intersection ID: 48160 | Main Street: NORTHLAKE CENTRE PY | Cross Street: N/A | Location: NE |

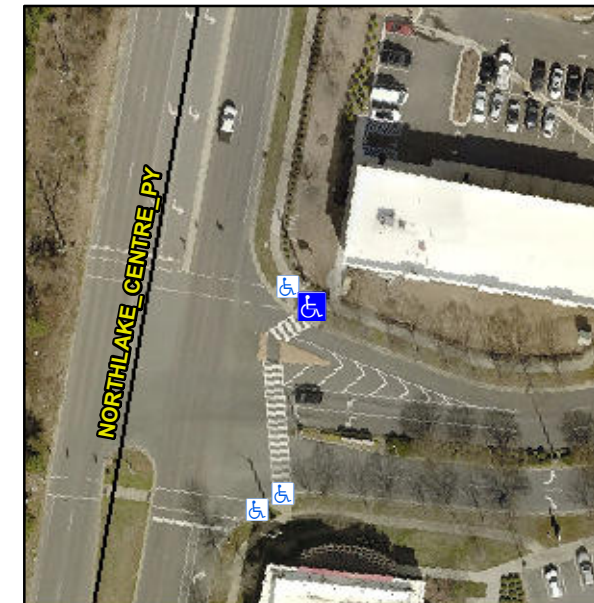
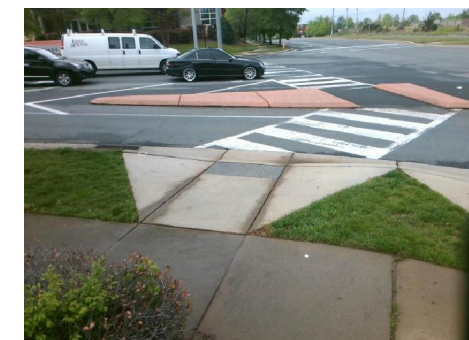
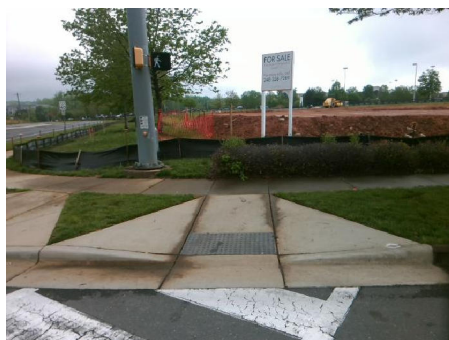
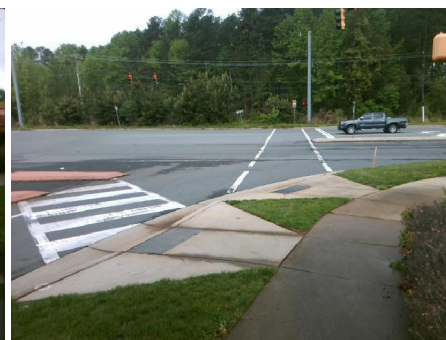
| ADA ID: 90436C02DF6A | Ramp Type: Perp | Initial Pass/Fail: Fail | Overall Compliance: No |

**Not Found, R304.5.1, R304.5.3**

| Compliance | Description | Data | Compliance | Description | Data |
|---|---|---|---|---|---|
| N/A | Ramp Length (in) | 96.0 | Yes | Ramp Slope (%) | 7.4 |
| No | Ramp Width (in) | 46.5 | No | Ramp XSlope (%) | 3.1 |

**Remove & Replace Entire Ramp.**

Total Cost: \$ 1850.00
