Access Compliance Report

Public Rights-of-Way

(Curb Ramps)

Intersection ID: N/A	Main Street: BARRINGER_DR	Cross Street: BRENTWOOD_PL	Location: SW
ADA ID: 906287F711D6	Ramp Type: Perp	Initial Pass/Fail: Fail	Overall Compliance: No
		Severity Score: 25

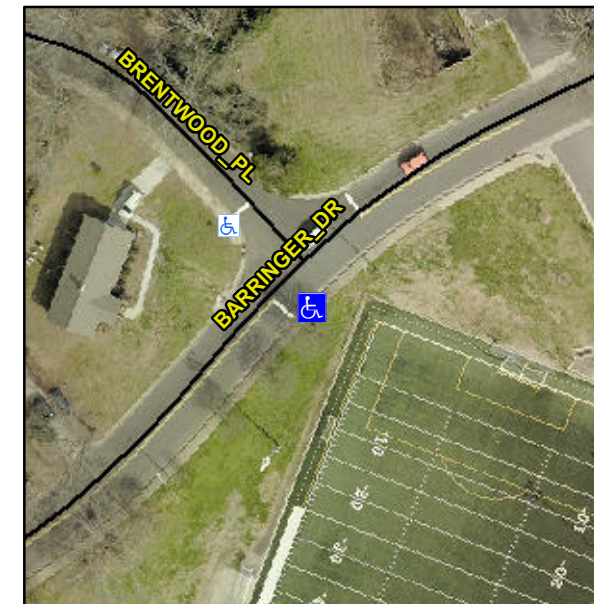
Not Found, R304.2.2, R304.5.3

Compliance	Description	Data	Compliance	Description	Data
N/A	Ramp Length (in)	60.0	No	Ramp Slope (%)	9.6
Yes	Ramp Width (in)	49.0	No	Ramp XSlope (%)	5.6
N/A	Flare Type LT	N/A	N/A	Flare Type RT	N/A
N/A	Flare Slope LT (%)	N/A	N/A	Flare Slope RT (%)	N/A
N/A	Flare Traversable LT?	N/A	N/A	Flare Traversable RT?	N/A
N/A	Landing Length (in)	N/A	N/A	DWS Provided?	N/A
N/A	Landing Width (in)	N/A	N/A	DWS Contrast?	N/A
N/A	Landing Slope (%)	N/A	N/A	DWS Length (in)	N/A
N/A	Landing X Slope (%)	N/A	N/A	DWS Full Width?	N/A
N/A	Landing Curb? (Y/N)	N/A	N/A	DWS Offset (in)	N/A
N/A	Shared Landing?	N/A			
N/A	Gutter Ponding?	N/A	N/A	Gutter Slope (%)	N/A
N/A	Gutter Lip Ht (in)	N/A	N/A	Gutter X Slope (%)	N/A
N/A	Painted X Walk1?	No	N/A	Painted X Walk2?	N/A
	X Walk 1 Direction	To N		X Walk 2 Direction	N/A
N/A	X Walk 1 Width (in)	N/A	N/A	X Walk 2 Width (in)	N/A
	X Walk 1 Slope (%)	3.6		X Walk 2 Slope (%)	N/A
	X Walk 1 X Slope (%)	4.3		X Walk 2 X Slope (%)	N/A

N/A	Ramp inside XWalk1?	N/A	N/A	Ramp inside XWalk2?	N/A
	Road Slope (%)	N/A	N/A	Clear Space?	N/A
	Road X Slope (%)	N/A	N/A	Clear Space to XWalk (in)	N/A
N/A	Any Obstructions?	N/A	N/A	Storm Grate/Utility Hazard?	N/A
	Obstruction Type			Storm Grate/Utility Type	
		N/A			N/A
			Yes	Surface Condition? (G/P)	Good

Remove & Replace Entire Ramp.
