## **Access Compliance Report Public Rights-of-Way** (Curb Ramps)

Intersection ID: 15478 Main Street: CUMBERLAND AV **Cross Street: E WORTHINGTON AV** Location: W ADA ID: 9083E3056BF7 Ramp Type: BlendTrans1 Initial Pass/Fail: Fail **Overall Compliance: No Severity Score:** 1.25

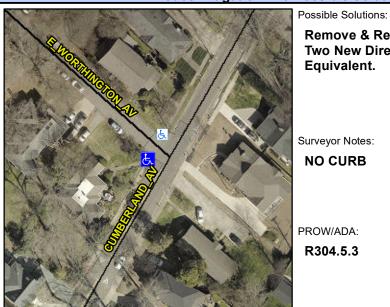
Surveyor Notes: **NO CURB**

Compliance Description Date		Data	Comp	liance Description	Data
N/A	Ramp Length (in)	36.0	Yes	BlendTrans Slope (%)	0.5
Yes	Ramp Width (in)	55.0	No	BlendTrans XSlope (%)	4.1
N/A	Flare Type LT	N/A	N/A	Flare Type RT	N/A
N/A	Flare Slope LT (%)	N/A	N/A	Flare Slope RT (%)	N/A
N/A	Flare Traversable LT?	N/A	N/A	Flare Traversable RT?	N/A
N/A	Landing Length (in)	N/A	N/A	DWS Provided?	N/A
N/A	Landing Width (in)	N/A	N/A	DWS Contrast?	N/A
N/A	Landing Slope (%)	N/A	N/A	DWS Length (in)	N/A
N/A	Landing X Slope (%)	N/A	N/A	DWS Full Width?	N/A
N/A	Landing Curb? (Y/N)	N/A	N/A	DWS Offset (in)	N/A
N/A	Shared Landing?	N/A			
N/A	Gutter Ponding?	N/A	N/A	Gutter Slope (%)	N/A
N/A	Gutter Lip Ht (in)	N/A	N/A	Gutter X Slope (%)	N/A
N/A	Painted X Walk1?	No	N/A	Painted X Walk2?	N/A
	X Walk 1 Direction	To NE		X Walk 2 Direction	N/A
	X Walk 1 Width (in)	N/A		X Walk 2 Width (in)	N/A
	X Walk 1 Slope (%)	1.6		X Walk 2 Slope (%)	N/A
	X Walk 1 X Slope (%)	9.6		X Walk 2 X Slope (%)	N/A

N/A	Ramp inside XWalk1?	N/A	N/A	Ramp inside XWalk2?	N/A
	Road Slope (%)	9.6		Clear Space?	N/A
	Road X Slope (%)	1.6	N/A	Clear Space to XWalk (in)	N/A
N/A	Any Obstructions?	N/A	N/A	Storm Grate/Utility Hazard?	N/A
	Obstruction Type			Storm Grate/Utility Type	
		N/A			N/A
			Yes	Surface Condition? (G/P)	Good

Remove & Replace Curb Ramp With Two New Directional Ramps or Equivalent.

R304.5.3
