Access Compliance Report

Public Rights-of-Way

(Curb Ramps)

Intersection ID: 14977	Main Street: BUCHANAN_ST	Cross Street: KENILWORTH_AV	Location: S
ADA ID: 908E2839E4D4	Ramp Type: Perp	Initial Pass/Fail: Fail	Overall Compliance: No
Severity Score: 1.25			
Codes/Mitigation Info/Possible Solution		Field Measurements/Component Compliance

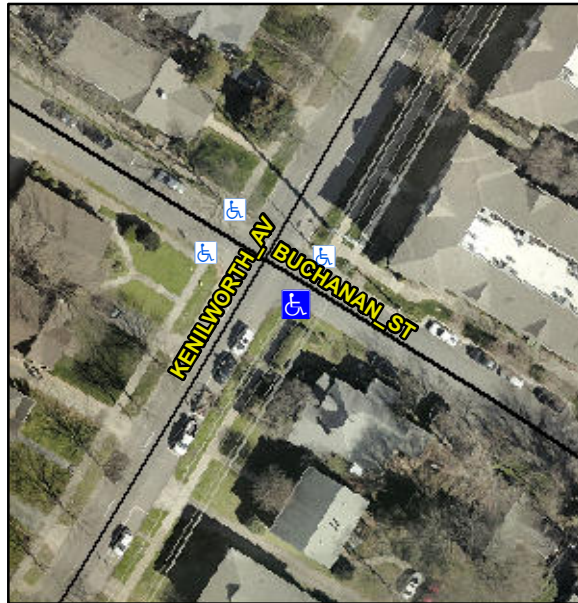
Not Found, R304.5.3

Compliance	Description	Data	Compliance	Description	Data
N/A	Ramp Length (in)	77.0	Yes	Ramp Slope (%)	5.4
Yes	Ramp Width (in)	48.0	No	Ramp XSlope (%)	4.7
N/A	Flare Type LT	N/A	N/A	Flare Type RT	N/A
N/A	Flare Slope LT (%)	N/A	N/A	Flare Slope RT (%)	N/A
N/A	Flare Traversable LT?	N/A	N/A	Flare Traversable RT?	N/A
N/A	Landing Length (in)	N/A	N/A	DWS Provided?	N/A
N/A	Landing Width (in)	N/A	N/A	DWS Contrast?	N/A
N/A	Landing Slope (%)	N/A	N/A	DWS Length (in)	N/A
N/A	Landing X Slope (%)	N/A	N/A	DWS Full Width?	N/A
N/A	Landing Curb? (Y/N)	N/A	N/A	DWS Offset (in)	N/A
N/A	Shared Landing?	N/A			
N/A	Gutter Ponding?	N/A	N/A	Gutter Slope (%)	N/A
N/A	Gutter Lip Ht (in)	1.0	N/A	Gutter X Slope (%)	N/A
N/A	Painted X Walk1?	No	N/A	Painted X Walk2?	N/A
	X Walk 1 Direction	To NE		X Walk 2 Direction	N/A
N/A	X Walk 1 Width (in)	N/A	N/A	X Walk 2 Width (in)	N/A
	X Walk 1 Slope (%)	0.3		X Walk 2 Slope (%)	N/A
	X Walk 1 X Slope (%)	3.2		X Walk 2 X Slope (%)	N/A

N/A	Ramp inside XWalk1?	N/A	N/A	Ramp inside XWalk2?	N/A
	Road Slope (%)	N/A	N/A	Clear Space?	N/A
	Road X Slope (%)	N/A	N/A	Clear Space to XWalk (in)	N/A
N/A	Any Obstructions?	N/A	N/A	Storm Grate/Utility Hazard?	N/A
	Obstruction Type			Storm Grate/Utility Type	
		N/A			N/A
			Yes	Surface Condition? (G/P)	Good

Possible Solutions:

Remove & Replace Entire Ramp.
