Access Compliance Report

Public Rights-of-Way

(Curb Ramps)

| Intersection ID: 27865 | Main Street: ALEXANDER_MILL_DR | Cross Street: MCCOMB_MANOR_CT | Location: SW |

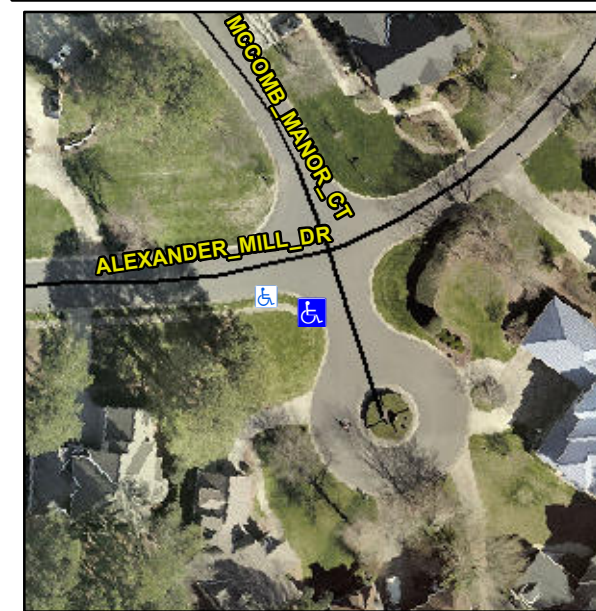
Not Found, R304.2.2, R304.5.3

| Compliance | Description | Data | Compliance | Description | Data |
|---|---|---|---|---|---|
| N/A | Ramp Length (in) | 38.0 | No | Ramp Slope (%) | 9.3 |
| Yes | Ramp Width (in) | 48.0 | No | Ramp XSlope (%) | 7.6 |

Possible Solutions:

Remove & Replace Entire Ramp.
