Access Compliance Report Public Rights-of-Way (Curb Ramps)

Intersection ID: 8969 Main Street: BEATTIES FORD RD **Cross Street: CELIA AV** Location: NW ADA ID: 90A01F869856 Ramp Type: PerpDiag Initial Pass/Fail: Fail **Overall Compliance: No** Severity Score: 21.25

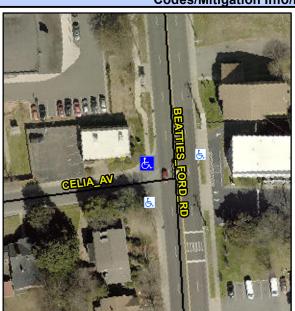
Field Measurements/Component Compliance Compliance Description Data Compliance Description Data					
N/A	Ramp Length (in)	58.0	No	Ramp Slope (%)	8.5
No	Ramp Width (in)	39.0	Yes	Ramp XSlope (%)	0.1
N/A	Flare Type LT	N/A	N/A	Flare Type RT	N/A
N/A	Flare Slope LT (%)	N/A	N/A	Flare Slope RT (%)	N/A
N/A	Flare Traversable LT?	N/A	N/A	Flare Traversable RT?	N/A
N/A	Landing Length (in)	N/A	N/A	DWS Provided?	N/A
N/A	Landing Width (in)	N/A	N/A	DWS Contrast?	N/A
N/A	Landing Slope (%)	N/A	N/A	DWS Length (in)	N/A
N/A	Landing X Slope (%)	N/A	N/A	DWS Full Width?	N/A
N/A	Landing Curb? (Y/N)	N/A	N/A	DWS Offset (in)	N/A
N/A	Shared Landing?	N/A	IV/A	DVVO Oliset (III)	IV/A
N/A	Gutter Ponding?	Yes	N/A	Gutter Slope (%)	N/A
N/A	Gutter Lip Ht (in)	N/A	N/A	Gutter X Slope (%)	N/A
N/A	Painted X Walk1?	No.	N/A	Painted X Walk2?	No.
N/A	X Walk 1 Direction	To S	IN/A	X Walk 2 Direction	To E
N/A			N/A		N/A
N/A	X Walk 1 Width (in)	N/A	N/A	X Walk 2 Width (in)

X Walk 1 Slope (%)	1.2		X Walk 2 Slope (%)	3.1
	X Walk 1 X Slope (%)	2.0		X Walk 2 X Slope (%)	2.6
N/A	Ramp inside XWalk1?	N/A	N/A	Ramp inside XWalk2?	N/A
	Road Slope (%)	0.4	N/A	Clear Space?	N/A
	Road X Slope (%)	4.5	N/A	Clear Space to XWalk (in)	N/A
N/A	Any Obstructions?	N/A	N/A	Storm Grate/Utility Hazard?	N/A
	Obstruction Type			Storm Grate/Utility Type	
		N/A			N/A
			Yes	Surface Condition? (G/P)	Good

Possible Solutions: Remove & Replace Curb Ramp With **Two New Directional Ramps or** Equivalent. Surveyor Notes: N/A PROW/ADA: Not Found, R304.5.1, R304.2.2
