# Access Compliance Report

## Public Rights-of-Way

### (Curb Ramps)

Intersection ID: 9530	Main Street: MCBRIDE_ST	Cross Street: THE_PLAZA	Location: W
ADA ID: 90AAE52AE0C3	Ramp Type: PerpDiag	Initial Pass/Fail: Fail	Overall Compliance: No
Severity Score: 13.75			
Codes/Mitigation Info/Possible Solution		Field Measurements/Component Compliance

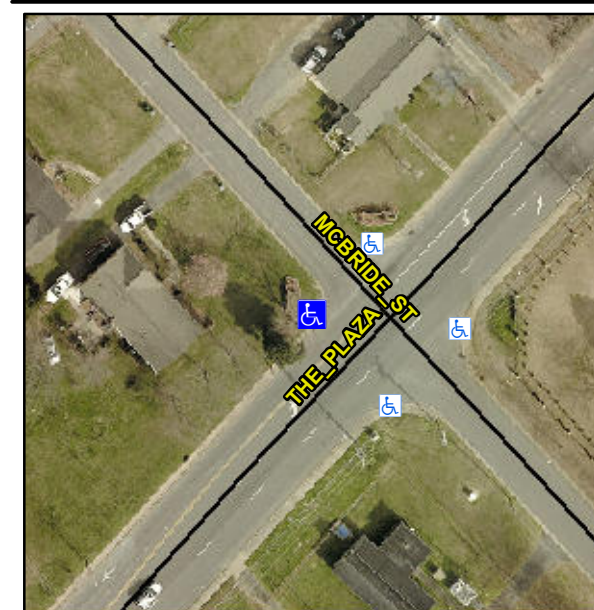
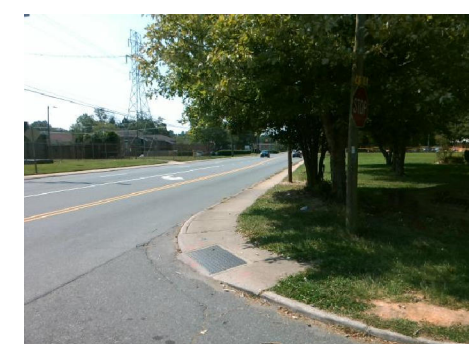
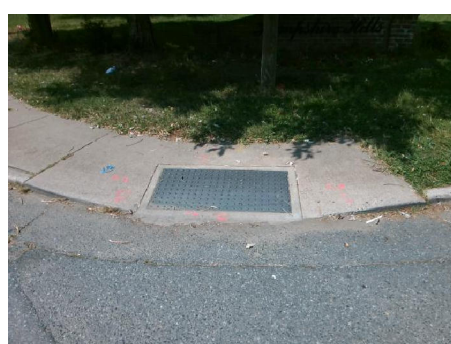
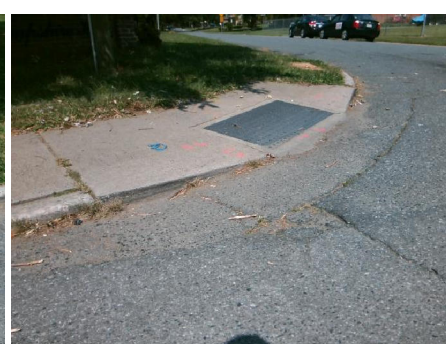
**Not Found, R304.2.2, R304.5.3**

Compliance	Description	Data	Compliance	Description	Data
N/A	Ramp Length (in)	54.0	No	Ramp Slope (%)	10.7
Yes	Ramp Width (in)	54.0	No	Ramp XSlope (%)	2.1
N/A	Flare Type LT	N/A	N/A	Flare Type RT	N/A
N/A	Flare Slope LT (%)	N/A	N/A	Flare Slope RT (%)	N/A
N/A	Flare Traversable LT?	N/A	N/A	Flare Traversable RT?	N/A
N/A	Landing Length (in)	N/A	N/A	DWS Provided?	N/A
N/A	Landing Width (in)	N/A	N/A	DWS Contrast?	N/A
N/A	Landing Slope (%)	N/A	N/A	DWS Length (in)	N/A
N/A	Landing X Slope (%)	N/A	N/A	DWS Full Width?	N/A
N/A	Landing Curb? (Y/N)	N/A	N/A	DWS Offset (in)	N/A
N/A	Shared Landing?	N/A			
N/A	Gutter Ponding?	N/A	N/A	Gutter Slope (%)	N/A
N/A	Gutter Lip Ht (in)	N/A	N/A	Gutter X Slope (%)	N/A
N/A	Painted X Walk1?	No	N/A	Painted X Walk2?	No
	X Walk 1 Direction	To SE		X Walk 2 Direction	To NE
N/A	X Walk 1 Width (in)	N/A	N/A	X Walk 2 Width (in)	N/A
	X Walk 1 Slope (%)	2.6		X Walk 2 Slope (%)	2.3
	X Walk 1 X Slope (%)	0.6		X Walk 2 X Slope (%)	0.8

N/A	Ramp inside XWalk1?	N/A	N/A	Ramp inside XWalk2?	N/A
	Road Slope (%)	0.8	N/A	Clear Space?	N/A
	Road X Slope (%)	3.8	N/A	Clear Space to XWalk (in)	N/A
N/A	Any Obstructions?	N/A	N/A	Storm Grate/Utility Hazard?	N/A
	Obstruction Type			Storm Grate/Utility Type	
		N/A			N/A
		Yes		Surface Condition? (G/P)	Good

**Remove & Replace Curb Ramp With Two New Directional Ramps or Equivalent.**

Total Cost: \$ 3200.00
