# Access Compliance Report

## Public Rights-of-Way

### (Curb Ramps)

Intersection ID: 11318	Main Street: GRANDIN_RD	Cross Street: W_4TH_ST_EXT	Location: S
ADA ID: 90C3D90D17C8	Ramp Type: BlendTrans1	Initial Pass/Fail: Fail	Overall Compliance: No
		Severity Score: 1.25

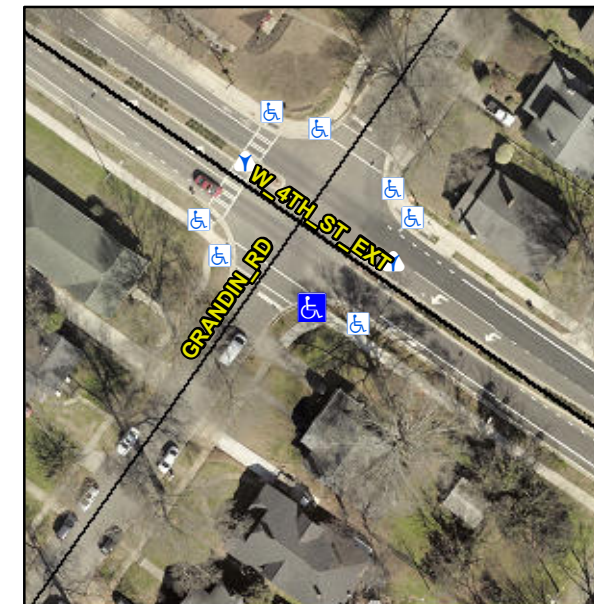
Compliance	Description	Data	Compliance	Description	Data
N/A	Ramp Length (in)	49.0	Yes	BlendTrans Slope (%)	3.0
Yes	Ramp Width (in)	69.0	No	BlendTrans XSlope (%)	2.8
N/A	Flare Type LT	N/A	N/A	Flare Type RT	N/A
N/A	Flare Slope LT (%)	N/A	N/A	Flare Slope RT (%)	N/A
N/A	Flare Traversable LT?	N/A	N/A	Flare Traversable RT?	N/A
N/A	Landing Length (in)	N/A	N/A	DWS Provided?	N/A
N/A	Landing Width (in)	N/A	N/A	DWS Contrast?	N/A
N/A	Landing Slope (%)	N/A	N/A	DWS Length (in)	N/A
N/A	Landing X Slope (%)	N/A	N/A	DWS Full Width?	N/A
N/A	Landing Curb? (Y/N)	N/A	N/A	DWS Offset (in)	N/A
N/A	Shared Landing?	N/A			
N/A	Gutter Ponding?	N/A	N/A	Gutter Slope (%)	N/A
N/A	Gutter Lip Ht (in)	N/A	N/A	Gutter X Slope (%)	N/A
N/A	Painted X Walk1?	No	N/A	Painted X Walk2?	N/A
	X Walk 1 Direction	To NW		X Walk 2 Direction	N/A
	X Walk 1 Width (in)	N/A		X Walk 2 Width (in)	N/A
	X Walk 1 Slope (%)	2.3		X Walk 2 Slope (%)	N/A
	X Walk 1 X Slope (%)	1.8		X Walk 2 X Slope (%)	N/A

N/A	Ramp inside XWalk1?	N/A	N/A	Ramp inside XWalk2?	N/A
	Road Slope (%)	1.8		Clear Space?	N/A
	Road X Slope (%)	2.3	N/A	Clear Space to XWalk (in)	N/A
N/A	Any Obstructions?	N/A	N/A	Storm Grate/Utility Hazard?	N/A
	Obstruction Type			Storm Grate/Utility Type	
		N/A			N/A
			Yes	Surface Condition? (G/P)	Good
			N/A	Curb Slope (%)	4.9

**Remove & Replace Curb Ramp With Two New Directional Ramps or Equivalent.**

**R304.5.3**
