# Access Compliance Report

## Public Rights-of-Way

### (Curb Ramps)

Intersection ID: 3683	Main Street: BROMPTON_LN	Cross Street: DAVIS_LAKE_PY	Location: SE
ADA ID: 90DBBD5CC973	Ramp Type: Perp	Initial Pass/Fail: Fail	Overall Compliance: No
Severity Score: 8.75			
Codes/Mitigation Info/Possible Solution		Field Measurements/Component Compliance

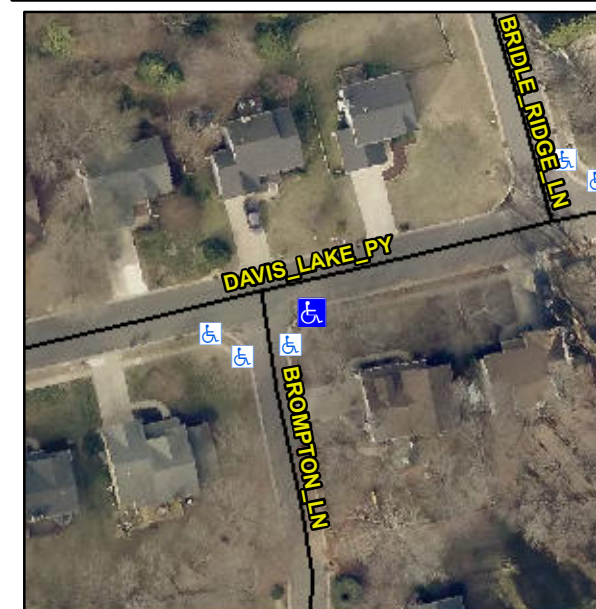
**Not Found, R304.5.1**

Compliance	Description	Data	Compliance	Description	Data
N/A	Ramp Length (in)	48.0	Yes	Ramp Slope (%)	6.7
No	Ramp Width (in)	46.5	Yes	Ramp XSlope (%)	0.2
N/A	Flare Type LT	N/A	N/A	Flare Type RT	N/A
N/A	Flare Slope LT (%)	N/A	N/A	Flare Slope RT (%)	N/A
N/A	Flare Traversable LT?	N/A	N/A	Flare Traversable RT?	N/A
N/A	Landing Length (in)	N/A	N/A	DWS Provided?	N/A
N/A	Landing Width (in)	N/A	N/A	DWS Contrast?	N/A
N/A	Landing Slope (%)	N/A	N/A	DWS Length (in)	N/A
N/A	Landing X Slope (%)	N/A	N/A	DWS Full Width?	N/A
N/A	Landing Curb? (Y/N)	N/A	N/A	DWS Offset (in)	N/A
N/A	Shared Landing?	N/A			
N/A	Gutter Ponding?	N/A	N/A	Gutter Slope (%)	N/A
N/A	Gutter Lip Ht (in)	N/A	N/A	Gutter X Slope (%)	N/A
N/A	Painted X Walk1?	No	N/A	Painted X Walk2?	N/A
	X Walk 1 Direction	To N		X Walk 2 Direction	N/A
N/A	X Walk 1 Width (in)	N/A	N/A	X Walk 2 Width (in)	N/A
	X Walk 1 Slope (%)	4.1		X Walk 2 Slope (%)	N/A
	X Walk 1 X Slope (%)	1.9		X Walk 2 X Slope (%)	N/A

N/A	Ramp inside XWalk1?	N/A	N/A	Ramp inside XWalk2?	N/A
	Road Slope (%)	N/A	N/A	Clear Space?	N/A
	Road X Slope (%)	N/A	N/A	Clear Space to XWalk (in)	N/A
N/A	Any Obstructions?	N/A	N/A	Storm Grate/Utility Hazard?	N/A
	Obstruction Type			Storm Grate/Utility Type	
		N/A			N/A
			Yes	Surface Condition? (G/P)	Good

**Remove & Replace Entire Ramp.**

Total Cost: \$ 1850.00
