# Access Compliance Report

## Public Rights-of-Way

### (Curb Ramps)

Intersection ID: 17865	Main Street: OVERHILL_RD	Cross Street: S_WENDOVER_RD	Location: NW
ADA ID: 90EA33C9BEF8	Ramp Type: PerpDiag	Initial Pass/Fail: Fail	Overall Compliance: No
		Severity Score: 12.5

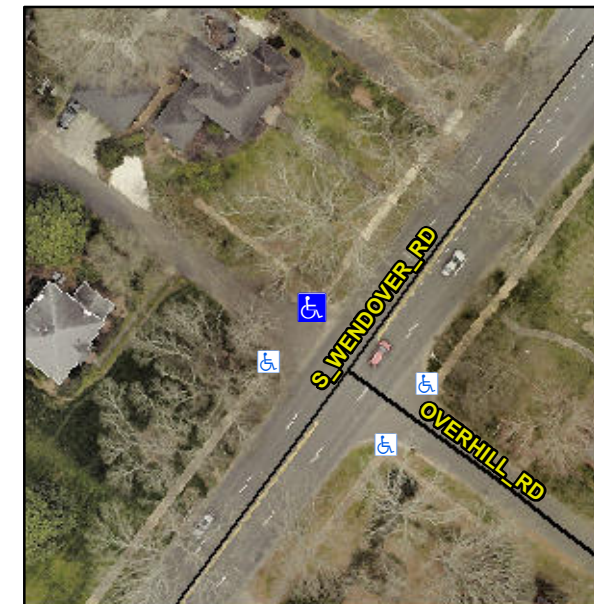
**Not Found, R304.5.3**

Compliance	Description	Data	Compliance	Description	Data
N/A	Ramp Length (in)	63.0	Yes	Ramp Slope (%)	6.5
Yes	Ramp Width (in)	48.0	No	Ramp XSlope (%)	6.0
N/A	Flare Type LT	N/A	N/A	Flare Type RT	N/A
N/A	Flare Slope LT (%)	N/A	N/A	Flare Slope RT (%)	N/A
N/A	Flare Traversable LT?	N/A	N/A	Flare Traversable RT?	N/A
N/A	Landing Length (in)	N/A	N/A	DWS Provided?	N/A
N/A	Landing Width (in)	N/A	N/A	DWS Contrast?	N/A
N/A	Landing Slope (%)	N/A	N/A	DWS Length (in)	N/A
N/A	Landing X Slope (%)	N/A	N/A	DWS Full Width?	N/A
N/A	Landing Curb? (Y/N)	N/A	N/A	DWS Offset (in)	N/A
N/A	Shared Landing?	N/A			
N/A	Gutter Ponding?	N/A	N/A	Gutter Slope (%)	N/A
N/A	Gutter Lip Ht (in)	N/A	N/A	Gutter X Slope (%)	N/A
N/A	Painted X Walk1?	No	N/A	Painted X Walk2?	No
	X Walk 1 Direction	To SW		X Walk 2 Direction	To SE
N/A	X Walk 1 Width (in)	N/A	N/A	X Walk 2 Width (in)	N/A
	X Walk 1 Slope (%)	0.4		X Walk 2 Slope (%)	2.0
	X Walk 1 X Slope (%)	5.6		X Walk 2 X Slope (%)	0.9

N/A	Ramp inside XWalk1?	N/A	N/A	Ramp inside XWalk2?	N/A
	Road Slope (%)	3.0	N/A	Clear Space?	N/A
	Road X Slope (%)	1.0	N/A	Clear Space to XWalk (in)	N/A
N/A	Any Obstructions?	N/A	N/A	Storm Grate/Utility Hazard?	N/A
	Obstruction Type			Storm Grate/Utility Type	
		N/A			N/A
		Yes		Surface Condition? (G/P)	Good

**Remove & Replace Curb Ramp With Two New Directional Ramps or Equivalent.**
