Access Compliance Report

Public Rights-of-Way

(Curb Ramps)

| Intersection ID: 3330 | Main Street: EDGEWEIR_CT | Cross Street: SPRING_PARK_DR | Location: NE |

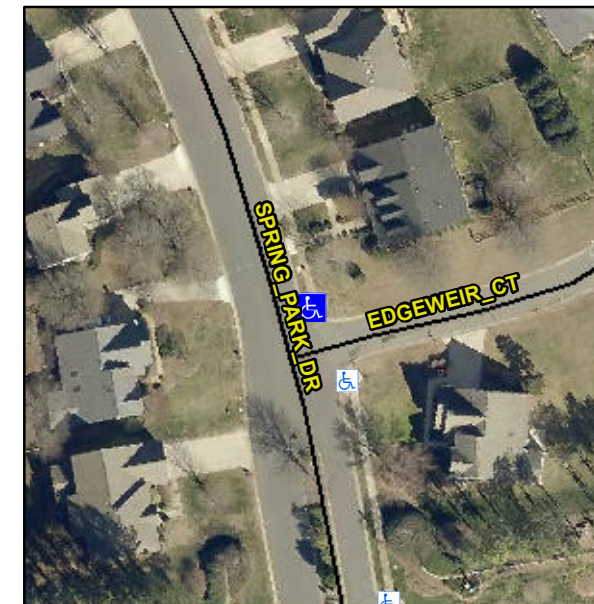
| ADA ID: 90F2645B57F8 | Ramp Type: Perp | Initial Pass/Fail: Fail | Overall Compliance: No |

Not Found, R304.5.1, R304.5.3

| Compliance | Description | Data | Compliance | Description | Data |
|---|---|---|---|---|---|
| N/A | Ramp Length (in) | 49.0 | Yes | Ramp Slope (%) | 5.0 |
| No | Ramp Width (in) | 39.0 | No | Ramp XSlope (%) | 4.0 |

Remove & Replace Entire Ramp.
