Access Compliance Report Public Rights-of-Way (Curb Ramps)

Main Street: COMMONWEALTH_AV Intersection ID: 13334 Cross Street: PECAN_AV Location: NE **Overall Compliance: No** ADA ID: 90F3EEECF995 Ramp Type: Perp Initial Pass/Fail: Fail **Severity Score:** 8.75

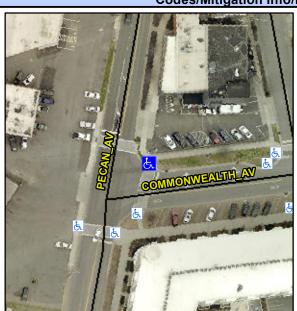
Remove & Replace Entire Ramp.			N/A	Ramp Length (in)	65.0	Yes	Ramp Slope (%)	6.4
				No	Ramp Width (in)	47.0	47.0 Yes Ramp XSlope (%)		0.7
				N/A	Flare Type LT	N/A	N/A	Flare Type RT	N/A
THE RESERVE AND ADDRESS OF THE PERSON NAMED IN COLUMN TO PERSON NAMED				N/A	Flare Slope LT (%)	N/A	N/A	Flare Slope RT (%)	N/A
S TO SERVE				N/A	Flare Traversable LT?	N/A	N/A	Flare Traversable RT?	N/A

N. 1155 1				N/A	Landing Length (in)	N/A	N/A	DWS Provided?	N/A
	Surveyor Notes:				Landing Width (in)	N/A	N/A	DWS Contrast?	N/A
± €	N/A			N/A	Landing Slope (%)	N/A	N/A	DWS Length (in)	N/A
MMONWEALTH AV				N/A	Landing X Slope (%)	N/A	N/A	DWS Full Width?	N/A
				N/A	Landing Curb? (Y/N)	N/A	N/A	DWS Offset (in)	N/A
8 8 8 9 6 6 6				N/A	Shared Landing?	N/A			
the state of the s	PROW/ADA:				Gutter Ponding?	N/A	N/A	Gutter Slope (%)	N/A
	Not Found, R304.5.1			N/A	Gutter Lip Ht (in)	N/A	N/A	Gutter X Slope (%)	N/A
Committee of a constitution of the party of	ŕ			N/A	Painted X Walk1?	Yes	N/A	Painted X Walk2?	N/A
1 ,					X Walk 1 Direction	To S		X Walk 2 Direction	N/A
				N/A	X Walk 1 Width (in)	150.0	N/A	X Walk 2 Width (in)	N/A
COMMONWEALTH AV					X Walk 1 Slope (%)	1.8		X Walk 2 Slope (%)	N/A
StopSign					X Walk 1 X Slope (%)	2.3		X Walk 2 X Slope (%)	N/A
N/A				N/A	Ramp inside XWalk1?	Yes	N/A	Ramp inside XWalk2?	N/A

Possible Solutions:	Compli	ance	Description	
Remove & Replace Entire Ramp.	N/A	I/A Ramp Length (in)		
·	No	Ramp Width (in)		
	N/A	Flare Type LT		
	N/A	Flare Slope LT (%)		
	N/A	Flare Traversable LT		
	N/A	Landi	ng Length (in)	
Surveyor Notes:	N/A	Landi	ng Width (in)	
N/A	N/A	Landi	ng Slope (%)	
	N/A	Landi	ng X Slope (%)	
	N/A	Landi	ng Curb? (Y/N)	
	N/A	Share	ed Landing?	
PROW/ADA:	N/A	Gutte	er Ponding?	
Not Found, R304.5.1	N/A	Gutte	er Lip Ht (in)	
	N/A	Paint	ed X Walk1?	
		X Wa	lk 1 Direction	
	N/A	X Wa	lk 1 Width (in)	
		X Wa	lk 1 Slope (%)	
		X Wa	lk 1 X Slope (%	
	N/A	Ramp	inside XWalk1	
		Road	Slope (%)
