Access Compliance Report Public Rights-of-Way (Curb Ramps)

Intersection ID: 46146 Main Street: ROCKY FORD CLUB RD Cross Street: BEAVER_CREEK_DR Location: SE ADA ID: 9105888EE298 Ramp Type: PerpDiag Initial Pass/Fail: Pass **Overall Compliance: No Severity Score:** 7.5

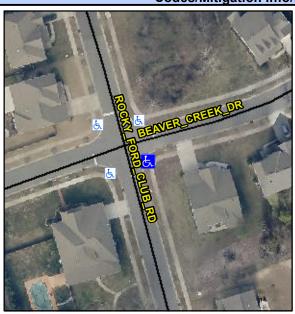
| Field Measurements/Component Compliance | | | | | |
|---|---|---|---|---|---|
| No | Gutter Ponding? | Yes | Yes | Gutter Slope (%) | 1.7 |
| No | Gutter Lip Ht (in) | 0.5 | Yes | Gutter X Slope (%) | 0.3 |

Possible Solutions: Remove & Replace Curb Slope and Extend Ramp. Surveyor Notes: N/A PROW/ADA: Not Found, R302.7, R302.7.2

Total Cost: 2000.00
